Frost Fish Creek Restoration Assessment Report

Chatham, Massachusetts

January 3, 2019

Prepared by the Association to Preserve Cape Cod's Restoration Coordination Center
for the Chatham Conservation Foundation

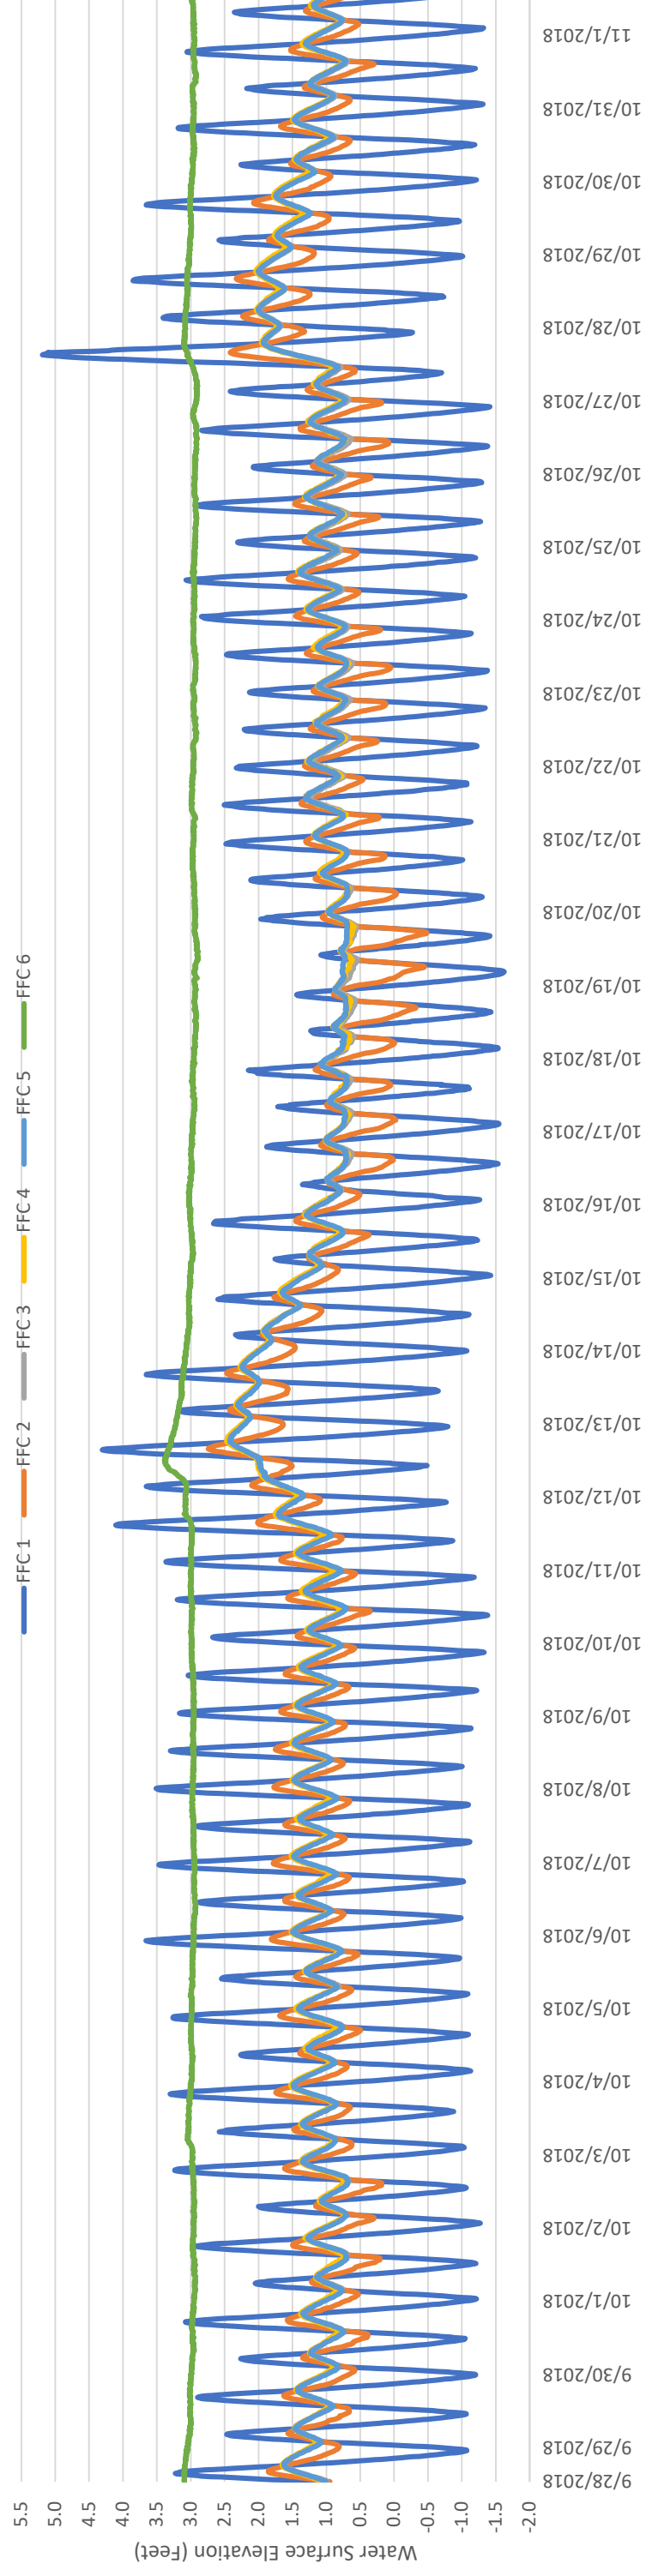
Frost Fish Creek Water Surface Elevation Plot Depicting Tidal Restrictions at Route 28 and Various Points Further Upstream

The resulting graph of water surface elevation (WSE) across all six locations confirms expected tidal restrictions between logger locations (Appendix E). The following table (Table 1) summarizes differences in average, maximum, minimum, and range of water surface elevation between monitoring locations in vertical feet relative to the NAVD 1988 vertical datum. Note that the total range as reported here differs significantly from the average daily range within each tidal cycle. For example, the average daily range in water surface elevation for logger FFC1 is approximately 4-ft, ranging in elevation from around 3ft to 1ft as opposed to the 6.81ft total range of the entire month-long data set, which accounts for the difference between the most extreme high and low tide events. To ascertain approximate average tidal range, or prism as it is often referred, refer to the WSE graph in Appendix E.

As expected, the most significant restriction was identified at the crossing of Route 28 where average tidal range for the full deployment period was reduced by 3.58-ft when comparing data from logger FFC1 with that of FFC2. At the Route 28 crossing, water ebbs and floods with the tides through concrete culverts. According to the 2006 Massachusetts Estuaries Project (MEP) report, there were three 1.5-ft diameter culverts beneath Route 28,⁴ although during our recent survey we only located two functional culverts. The third may be collapsed or clogged and does not appear to be conveying water in any significant amount, thus it is likely that the extent of the tidal restriction has increased since the last hydrologic assessment as documented in the 2003 MEP report.

A secondary tidal restriction was identified at an earthen berm approximately 200-ft upstream from Route 28 where tidal range is further reduced by an additional 1.32-ft based on comparison of average tidal range between loggers FFC2 and FFC3 during our survey period. This second restriction occurs just upstream of the area referred to as “the pond” for this report where water flows swiftly through an earthen berm via a single 30-inch concrete culvert pipe. During our survey we observed evidence that high water may occasionally breach the top of this berm (see photo titled “Pond berm eroded channel”) and found the culvert to be in poor condition as water was observed gurgling out of the top of the culvert pipe and around the concrete weir structure and headwall. It’s also worthy to note that the powerful flow rate through this culvert is a significant hazard to both humans and animals. There is no protective fencing and an animal, child, or adult human could easily be drawn into the culvert if venturing too close during peak tidal flow.

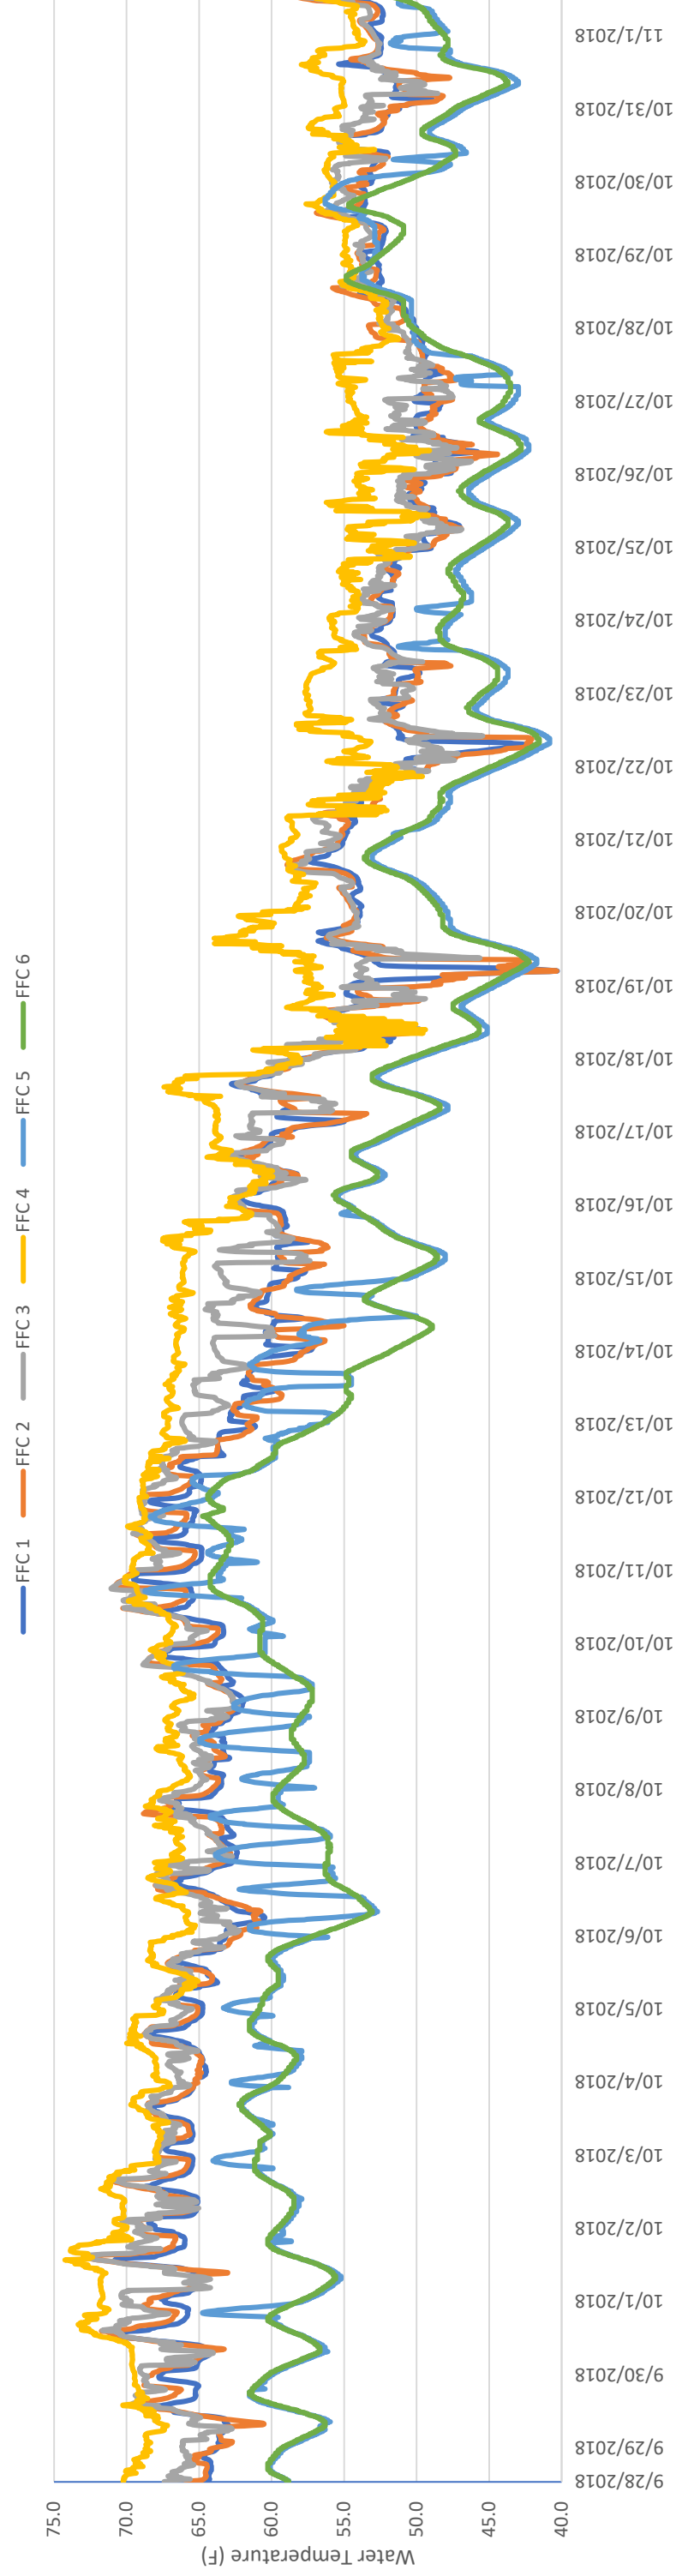
Frost Fish Creek Water Temperature Plot North of Route 28 and at Various Points Further Upstream

As expected, water temperature at all six loggers varied daily due to tides, solar energy and weather and followed an overarching decreasing trend throughout the survey period as the summer's warmth radiated out into the cooler fall air. Interestingly, water temperature in the bog at FFC6 and immediately downstream of the bog at logger FFC5 was consistently the lowest in the system (Table 2). FFC5 showed spikes in temperature when tidal water warmed the upper reaches of the system but otherwise mirrored temps reported at FFC6 (Appendix E). This finding suggests that there is significant groundwater flow entering the bog area, which has a consistent cool temperature in the mid-50's Fahrenheit in Cape Cod's aquifer. Much of the bog area is surrounded by steep hillsides, which often coincide with areas of steep water table elevation gradient where groundwater enters surface waters at higher rates. In the absence of precipitation and with no other surface water inputs, the water flow exiting the bog at the water control structure by FFC5 and FFC6 may be a good approximation of the rate of groundwater entering the bog.
