# Eyes Over Puget Sound

## Surface Conditions Report, *June 6, 2017*

*Up-to-date observations of water quality conditions in Puget Sound and coastal bays*

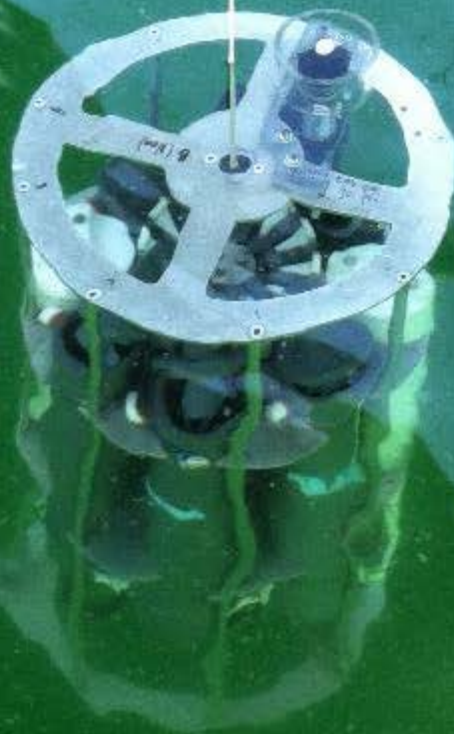
We use a SeaBird CTD (Conductivity, Temperature, Depth) profiler with added sensors to measure a suite of water column parameters:

- Temperature
- Salinity/Conductivity
- Dissolved oxygen
- PAR (Light)
- Transmissivity
- Fluorometry
- Turbidity
- pH

Surrounding the sensors are water-sampling Niskin bottles that we can program to collect water samples at discrete depths. We analyze:

- Nutrients
- Chlorophyll *a*
- TN (Total nitrogen)
- TOC (Total organic carbon)
- POC (Particulate organic carbon)
- PN (Particulate organic nitrogen)
- Dissolved oxygen
- Salinity

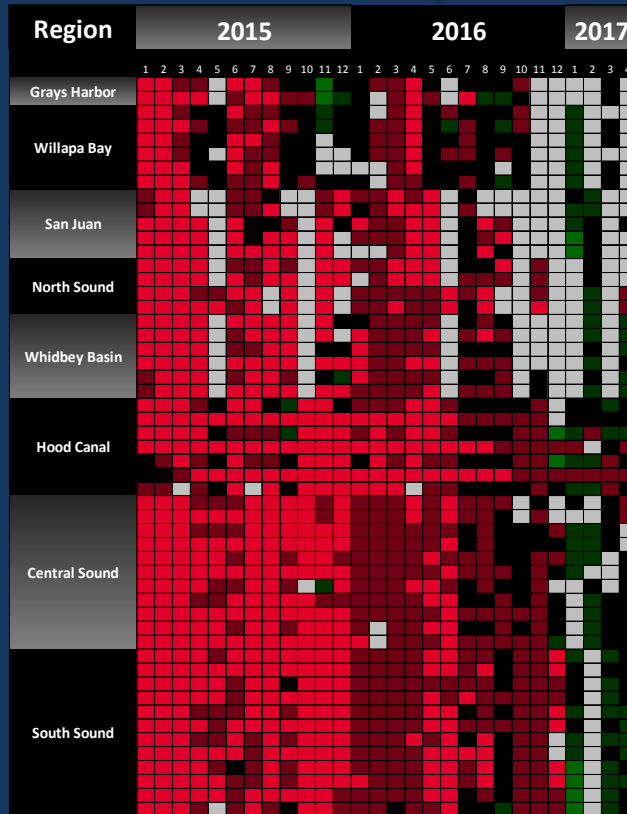
## Cooler Temperature

With the onset of 2017, the remarkably high water temperatures from 2015 & 2016 disappeared except in South Hood Canal deep water. **Record winter and spring rains** have created significantly fresher conditions. Bad weather from Jan. – Apr., 2017 caused us to miss quite a few stations. In addition, our rigorous QA/QC caught some sensor issues in oxygen, resulting in data gaps.

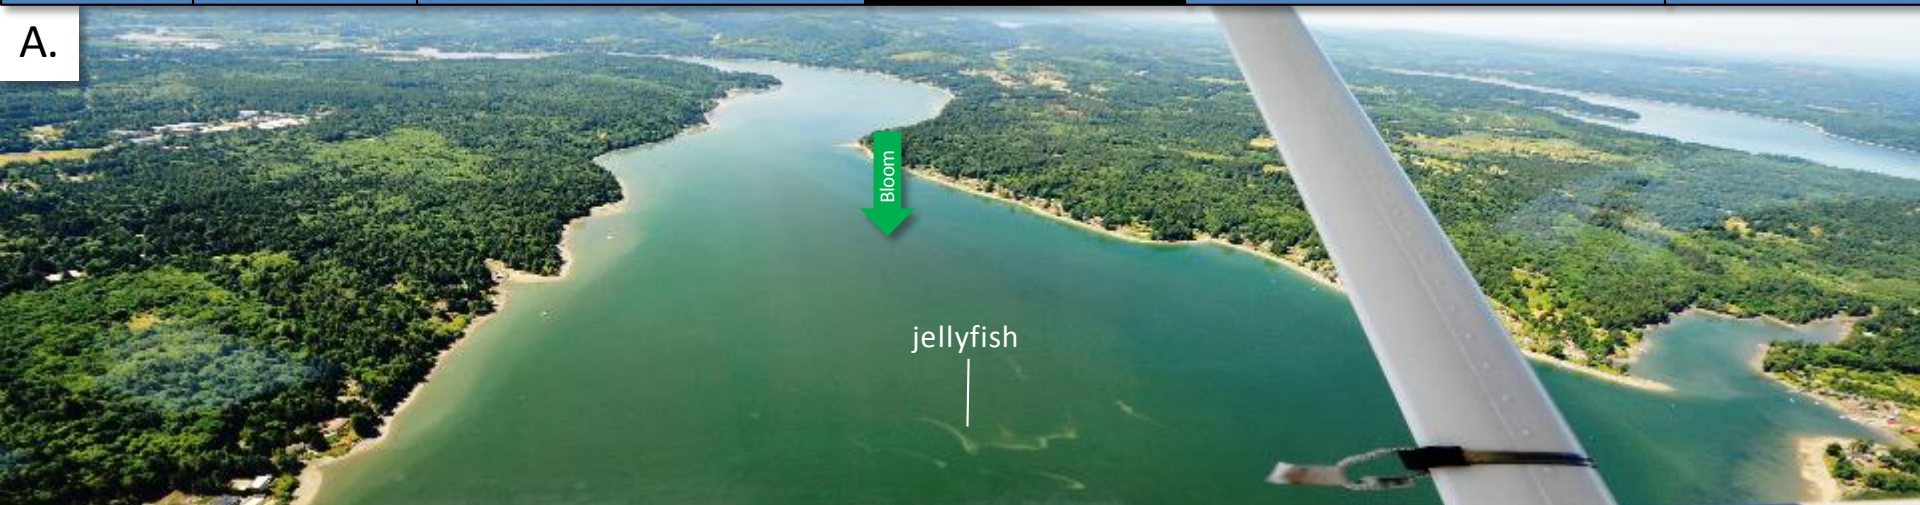
*A. Jellyfish patches and small bloom. B. Aquaculture and effects on surface layer during incoming tide.*  
Location: A. Eld Inlet, B. Totten Inlet (South Sound), 1:02 PM.

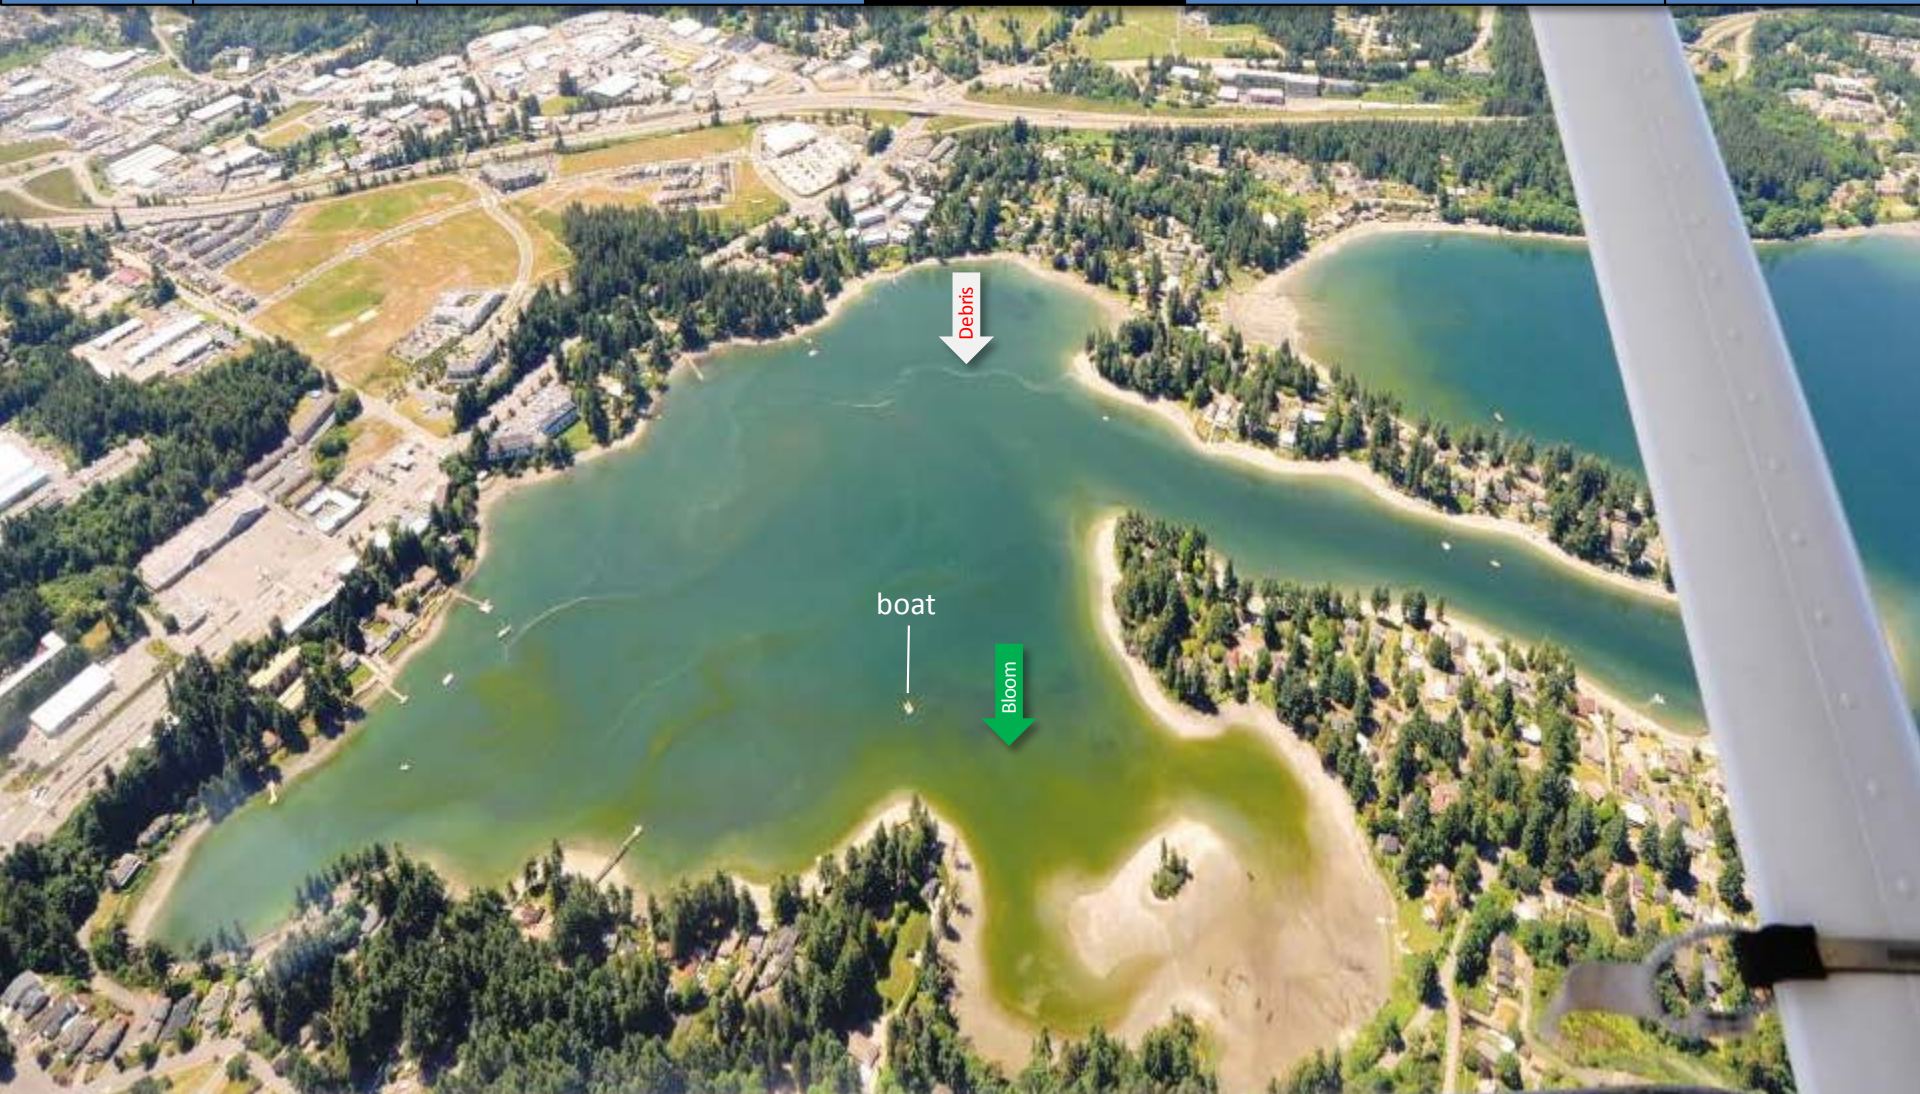
Location: Oyster Bay/Dyes Inlet (Central Sound), 1:27 PM.

*Bright yellow-green bloom.*

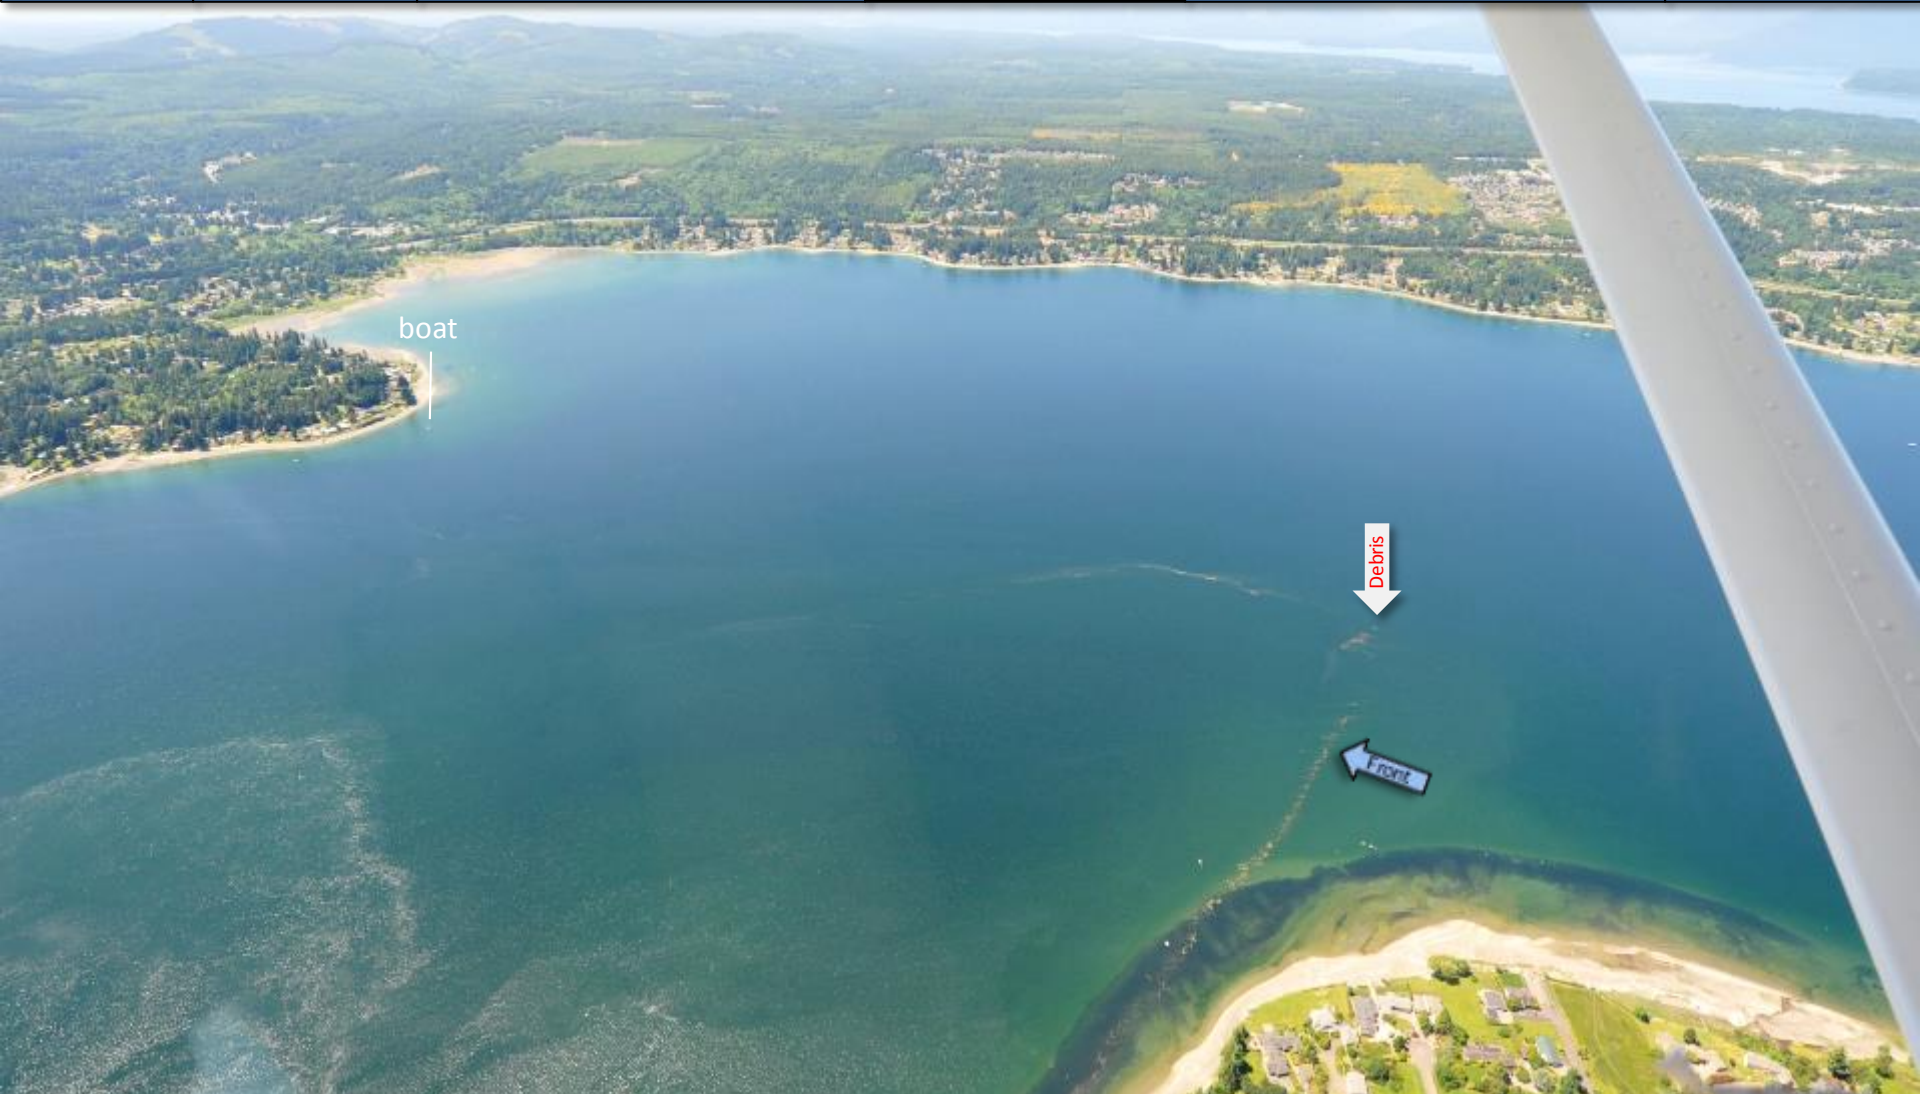
*Macro algae accumulating along tidal frontline.*  
Location: Off Windy Point/Dyes Inlet (Central Sound), 1:29 PM.

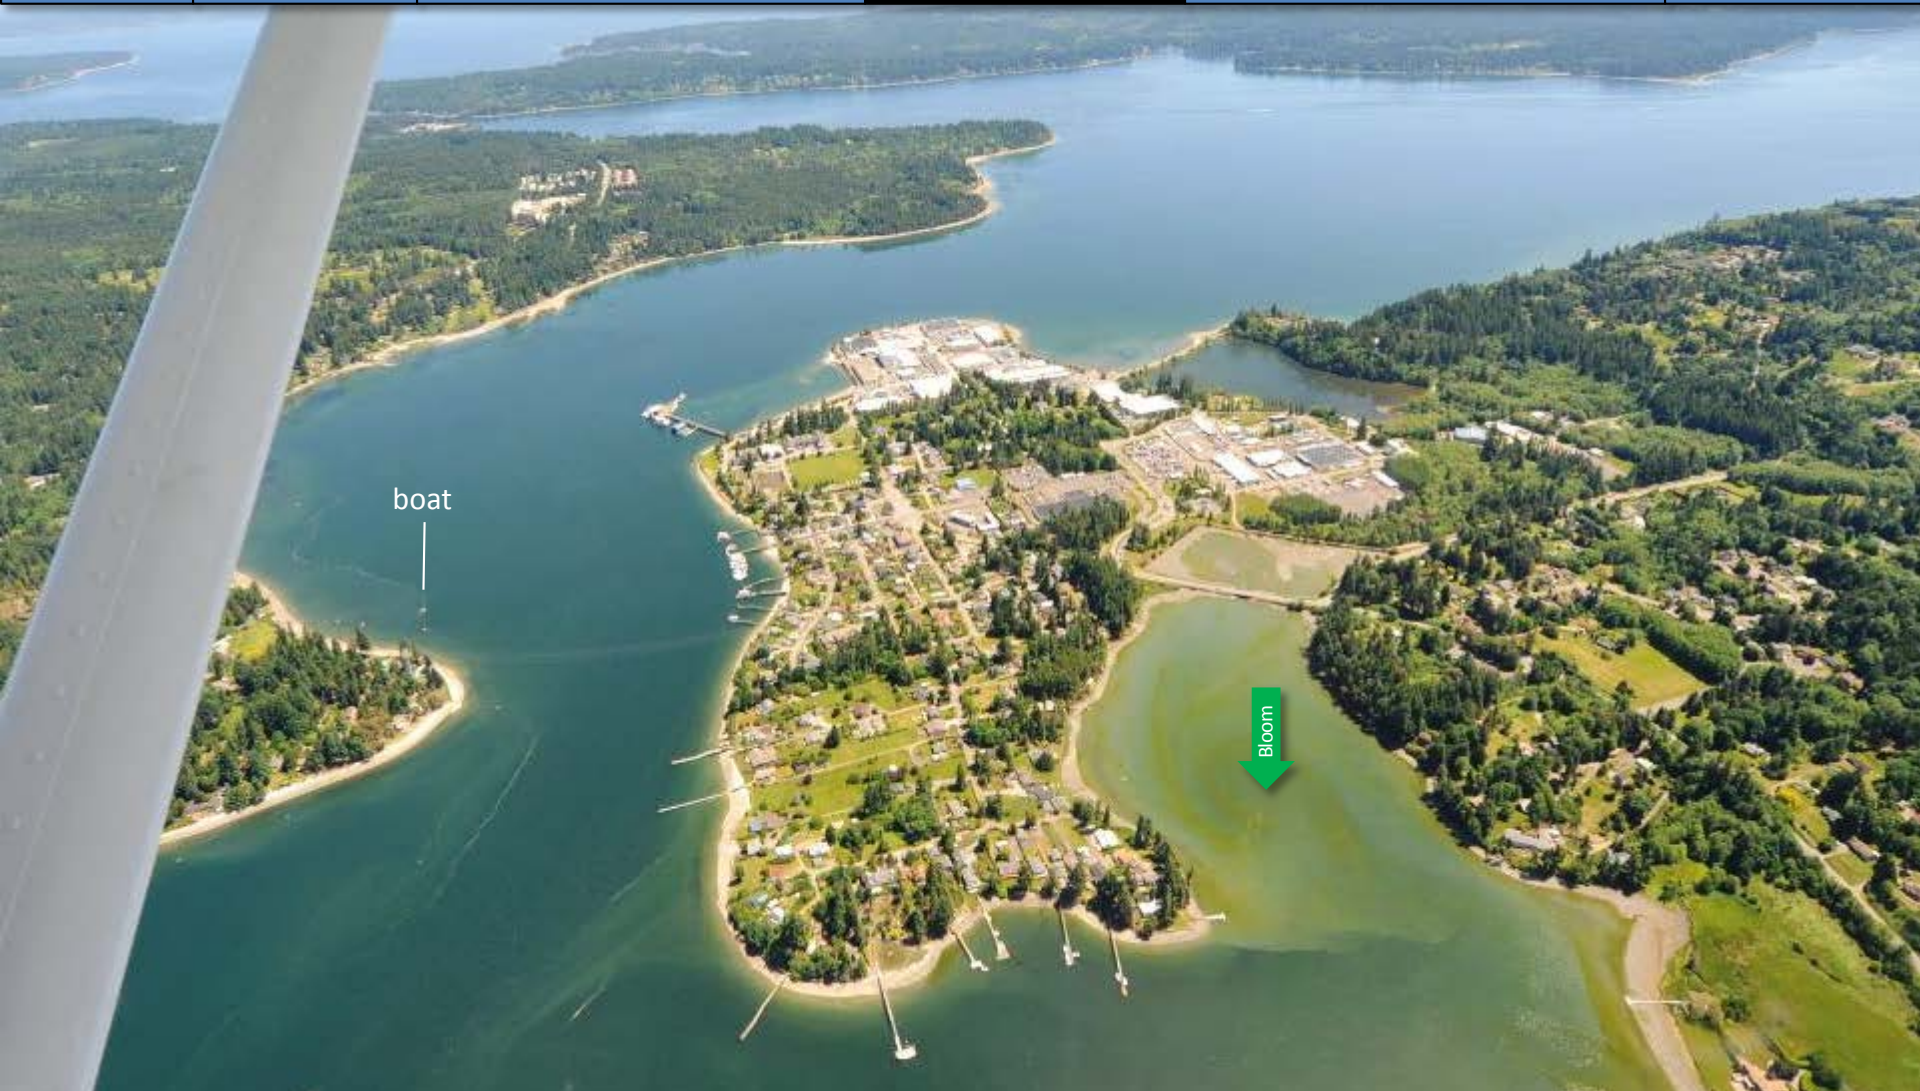
Location: Off Keyport Saltwater Park, Liberty Bay (Central Sound), 1:32 PM.

*Bright yellow-green bloom.*

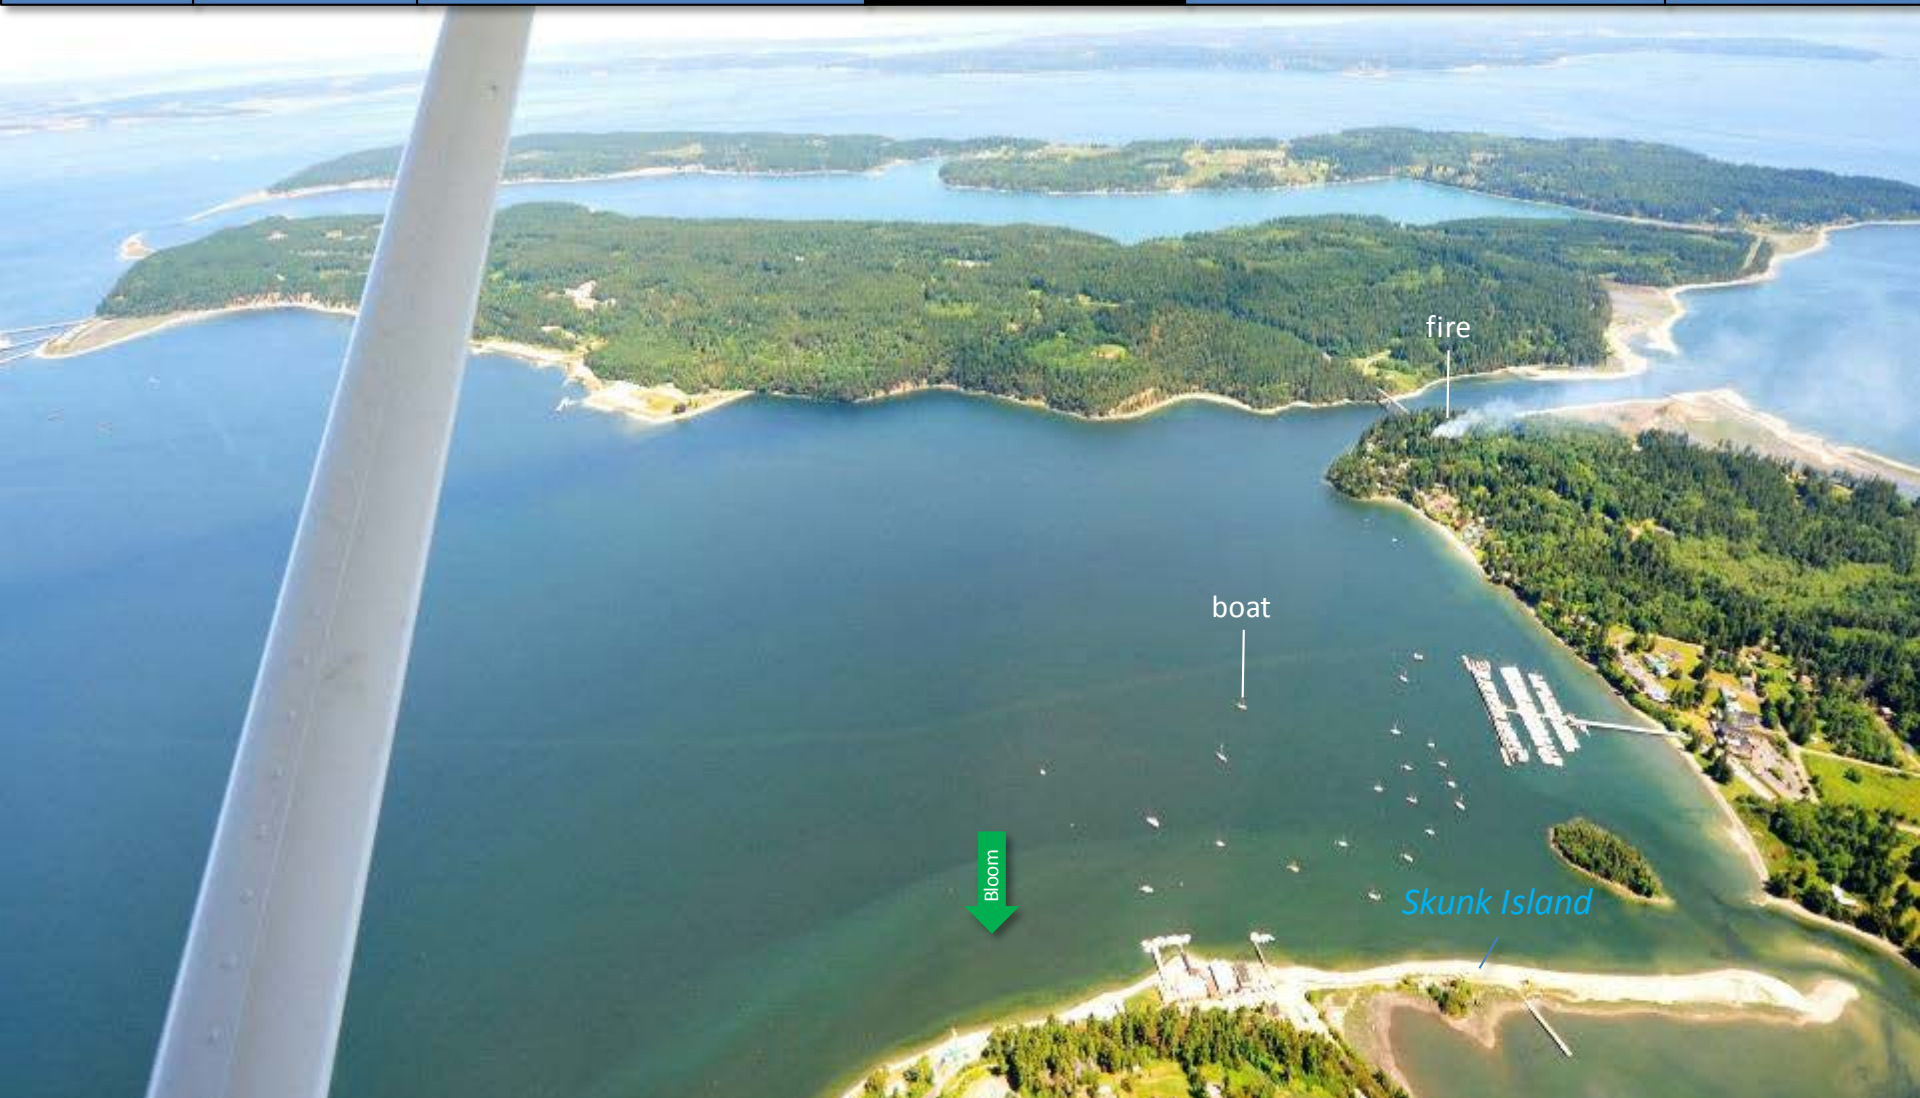
Location: *Port Hadlock, Port Townsend Bay (Central Sound), 1:46 PM.*

*Bloom and freshwater plume near Skunk Island.*

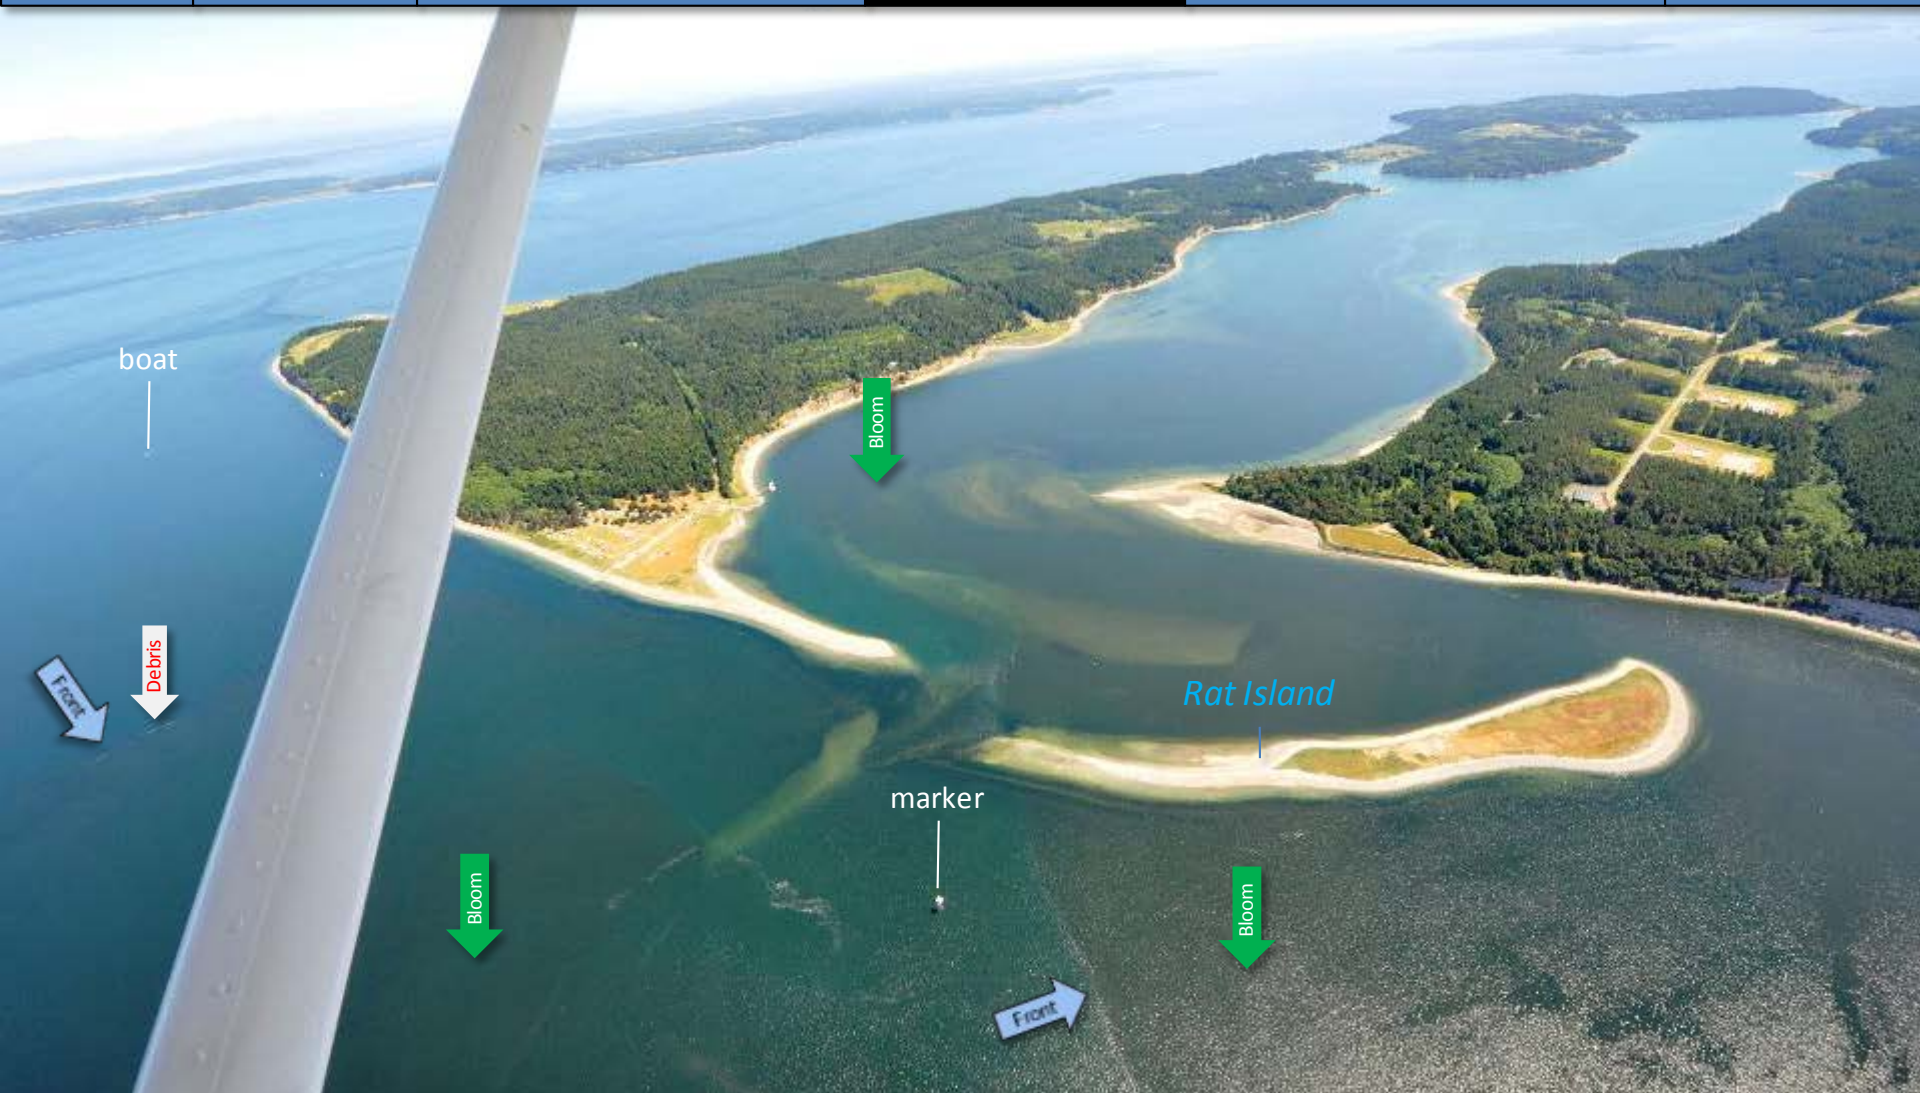
Location: Port Townsend Bay (Central Sound), 1:49 PM.

*Bloom extending into Kilisut Harbor.*

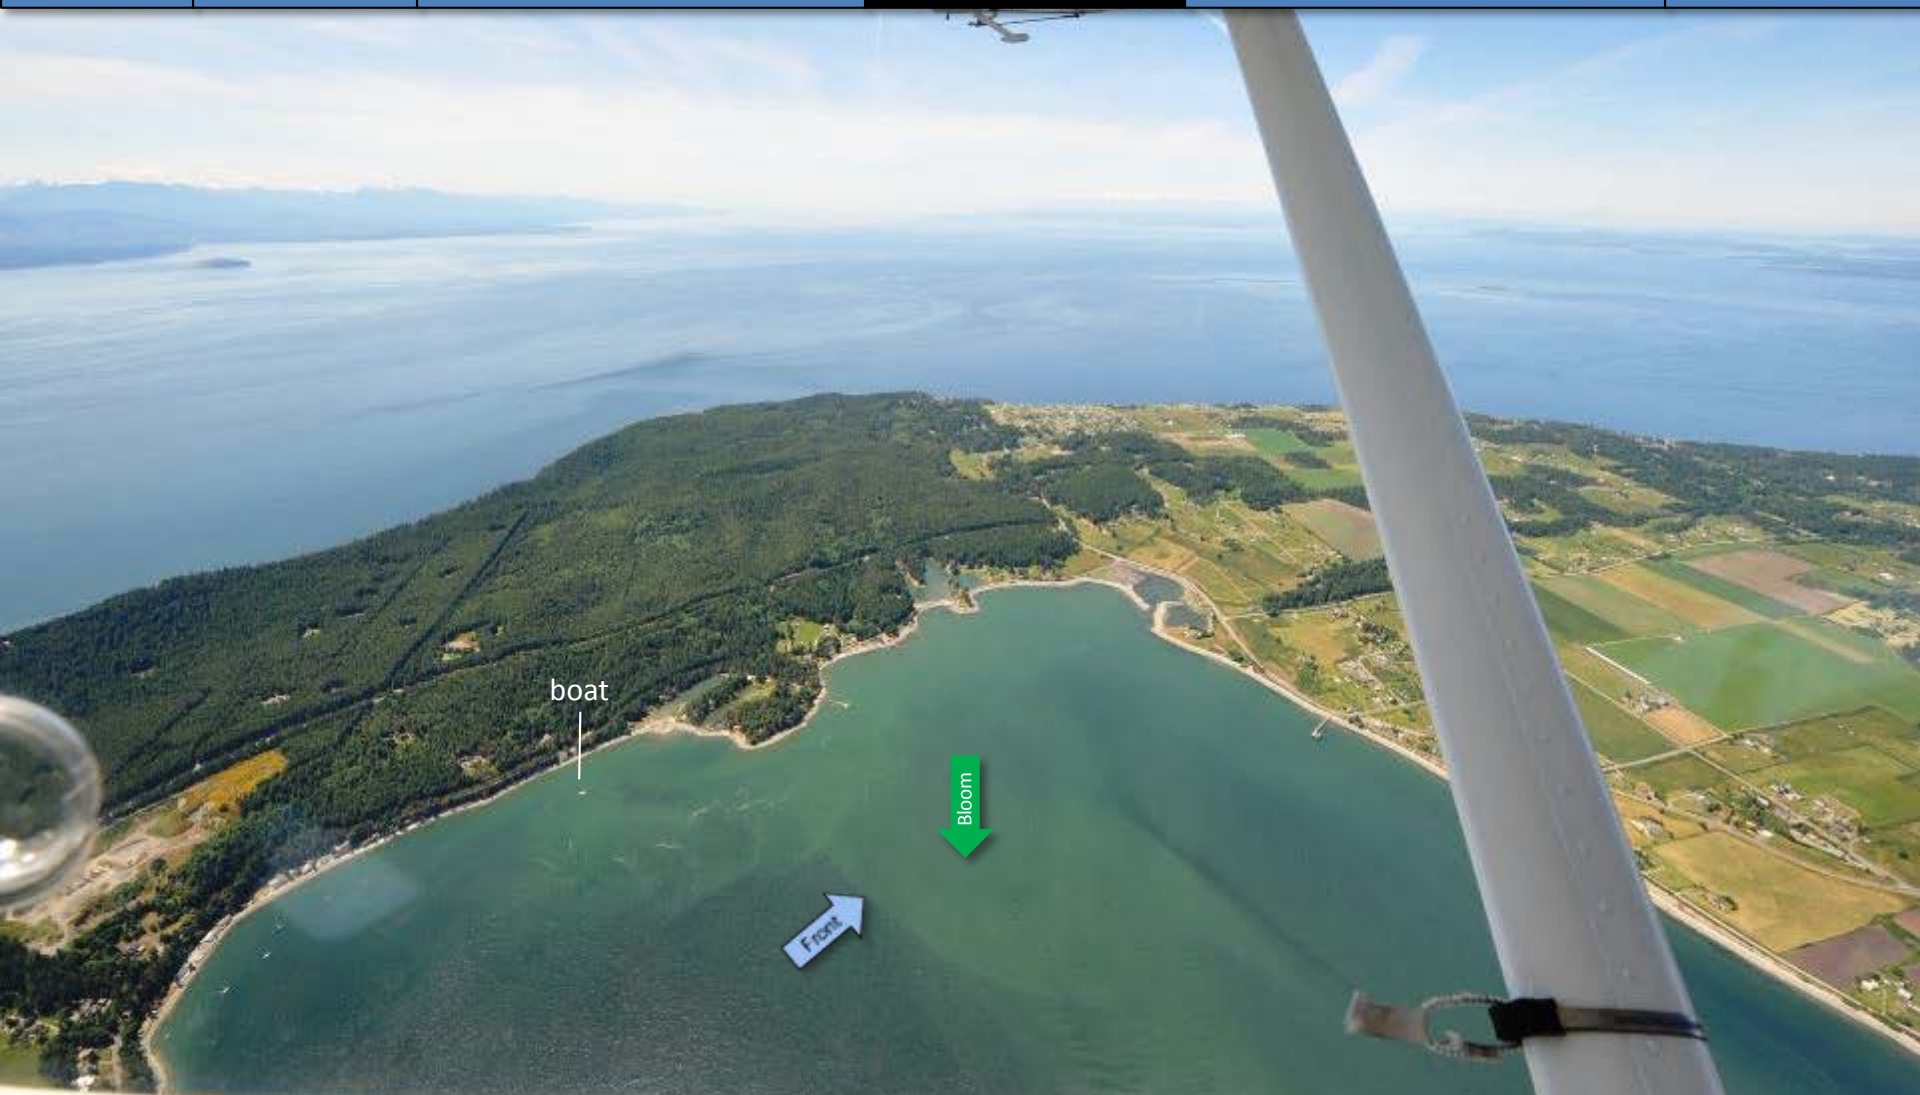
*Skagit Sediment plume extending into Penn Cove.*  
Location: Penn Cove (Whidbey Basin), 1:54 PM.

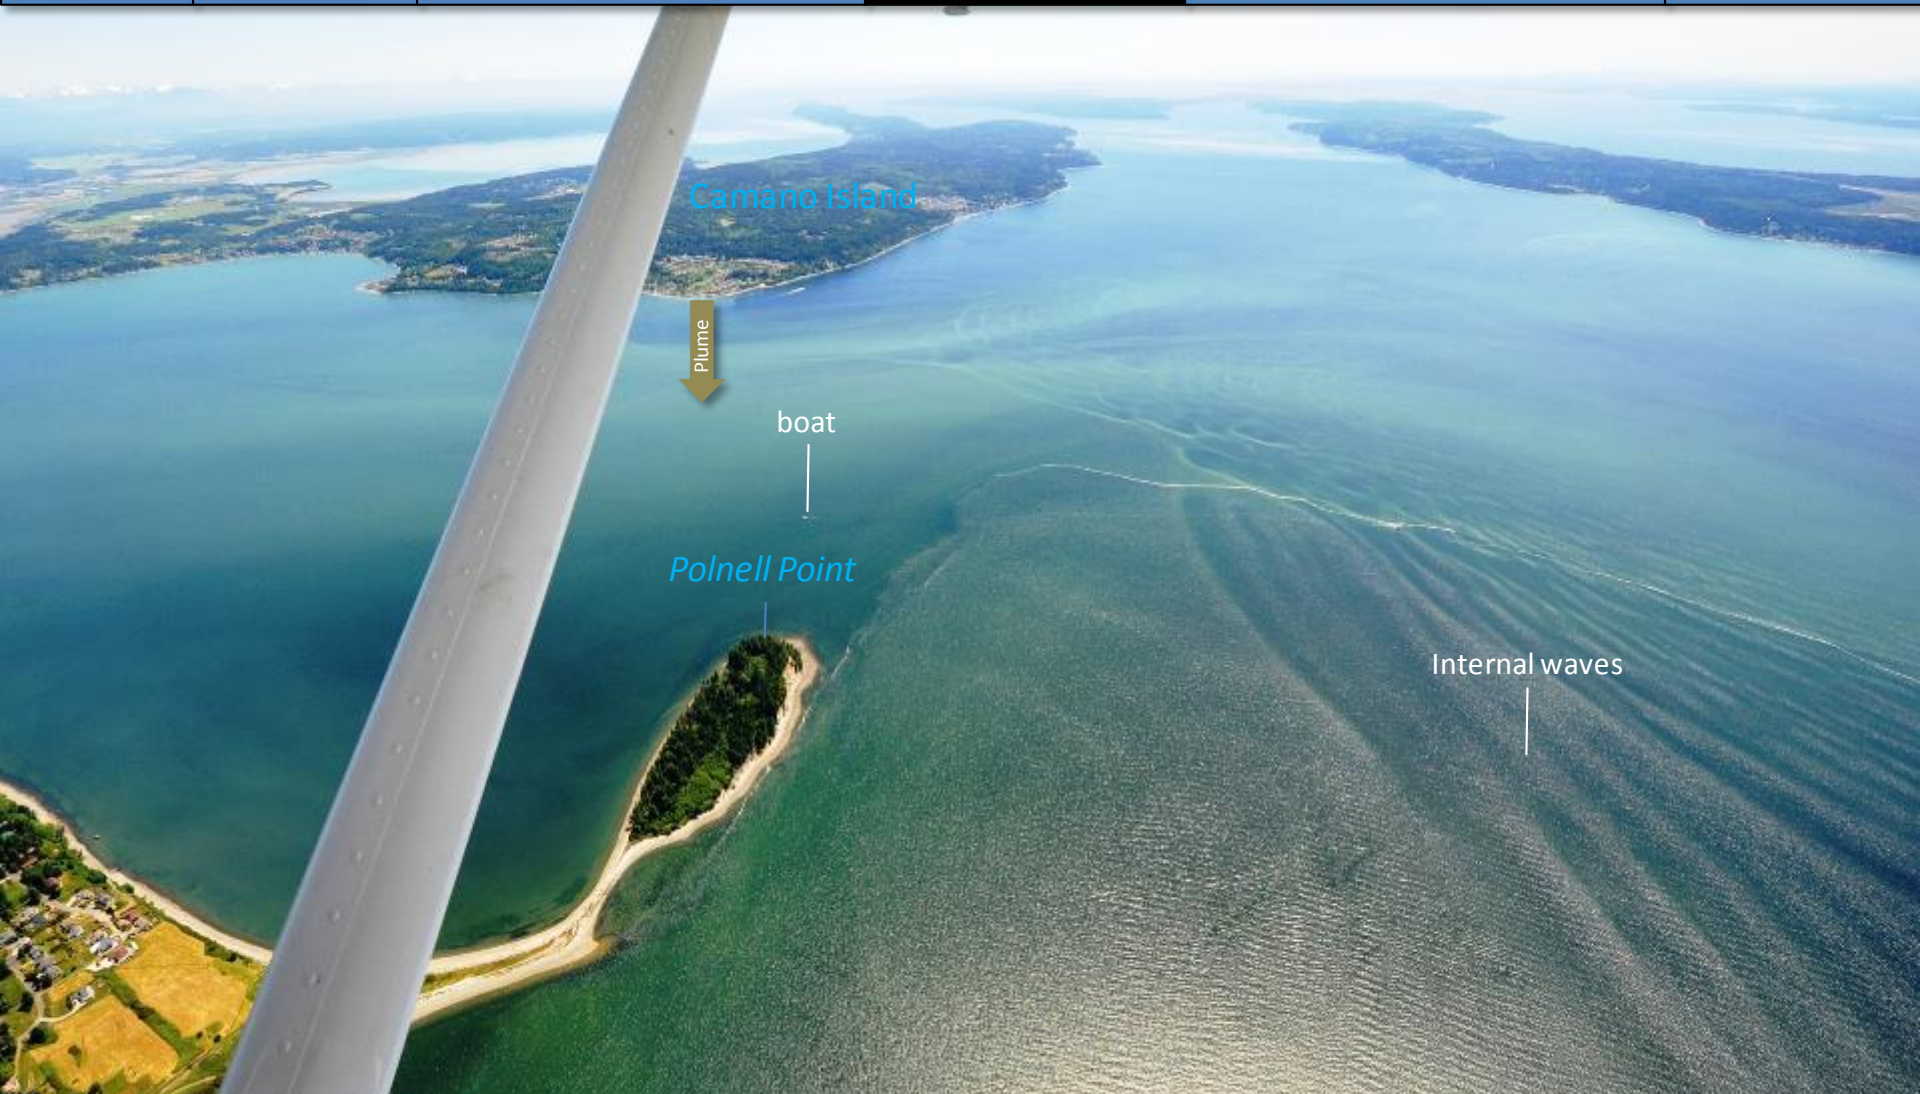
*A train of internal wave traveling towards Skagit Bay.*  
Location: Entrance to Skagit Bay (Whidbey Basin), 1:59 PM.

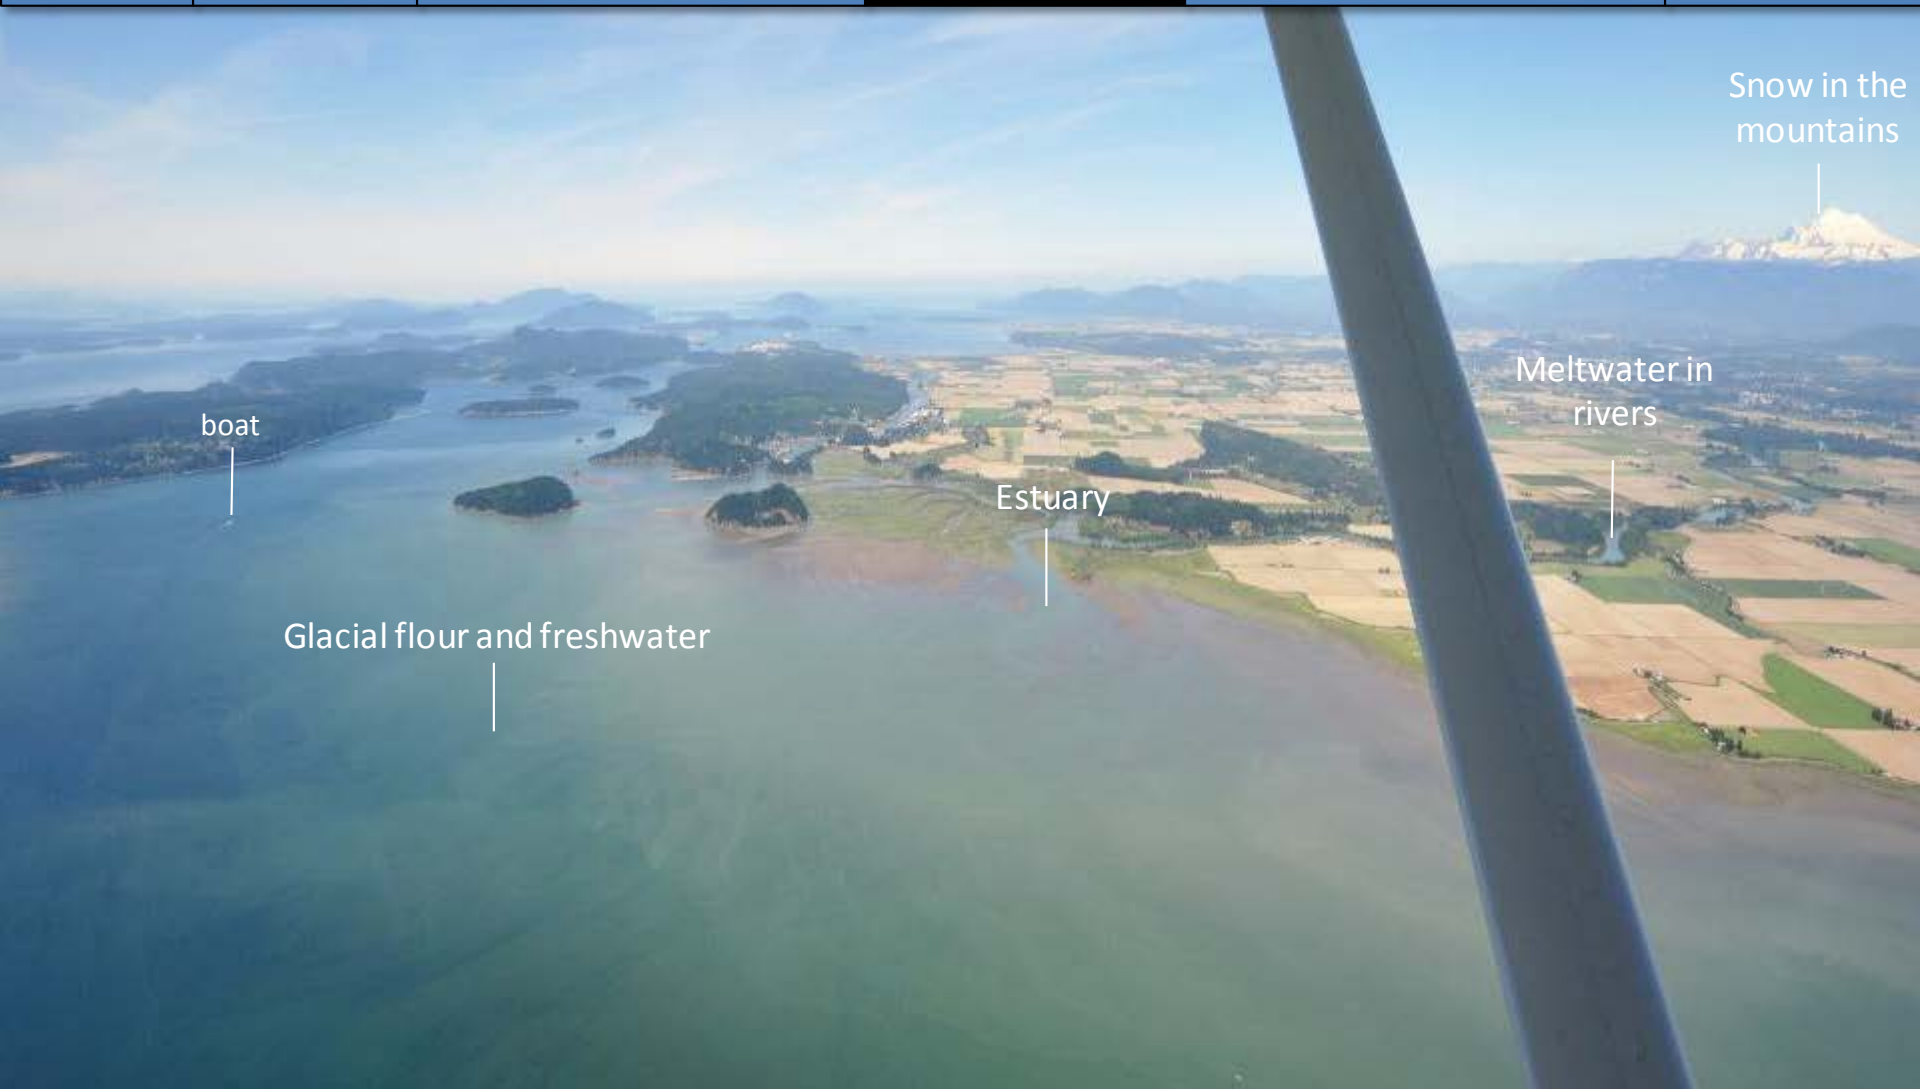
Location: North Fork Skagit River, Skagit Bay (Whidbey Basin), 2:01 PM.

*Fed by meltwater in the mountains, the Skagit River is the largest freshwater contributor to Puget Sound.*

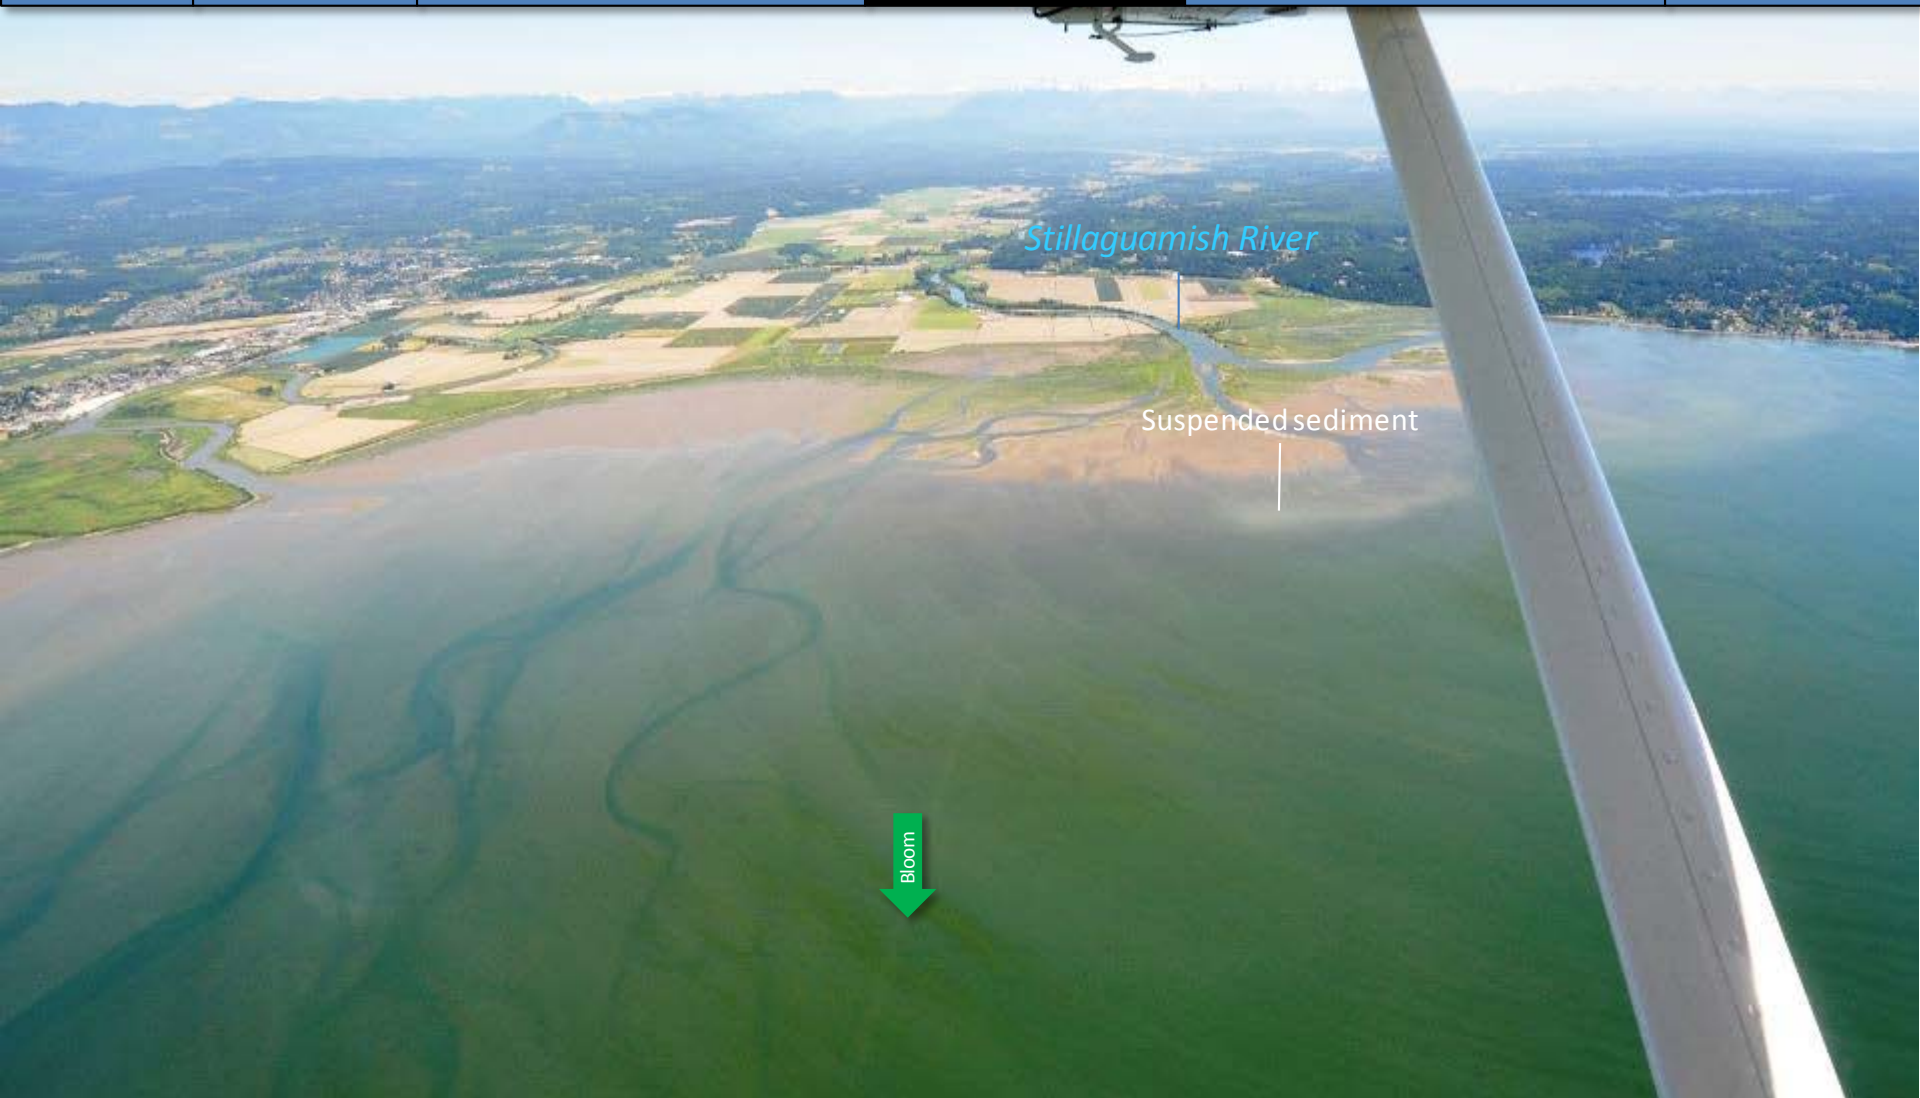
*Bloom in shallow stratified water of the Stillaguamish River Estuary.  
Location: Totten Inlet (South Sound), 2:06 PM.*
