# Eyes Over Puget Sound

## Surface Conditions Report, *June 6, 2017*

*Up-to-date observations of water quality conditions in Puget Sound and coastal bays*

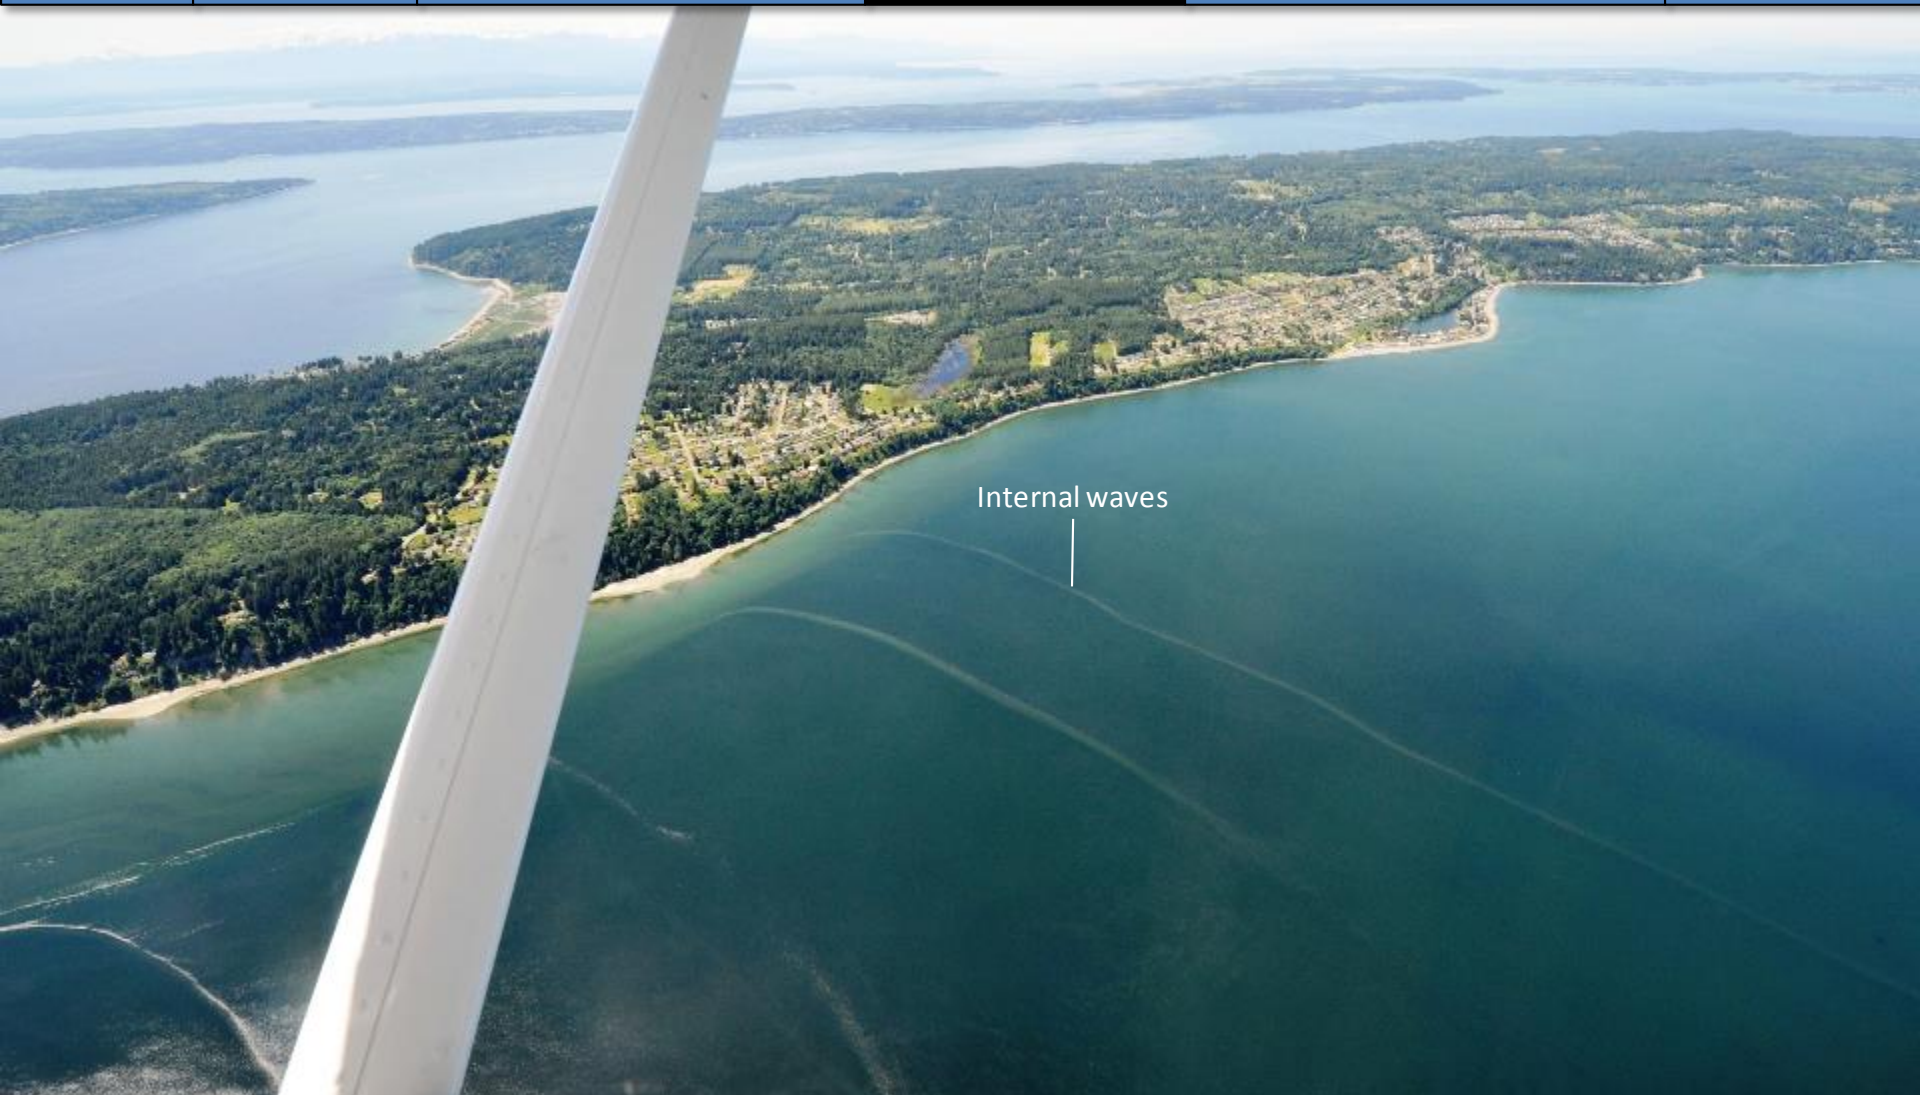
*Internal waves running northward curving in shallow water of Camano Island.*  
Location: Port Suzan (Whidbey Basin), 2:08 PM.

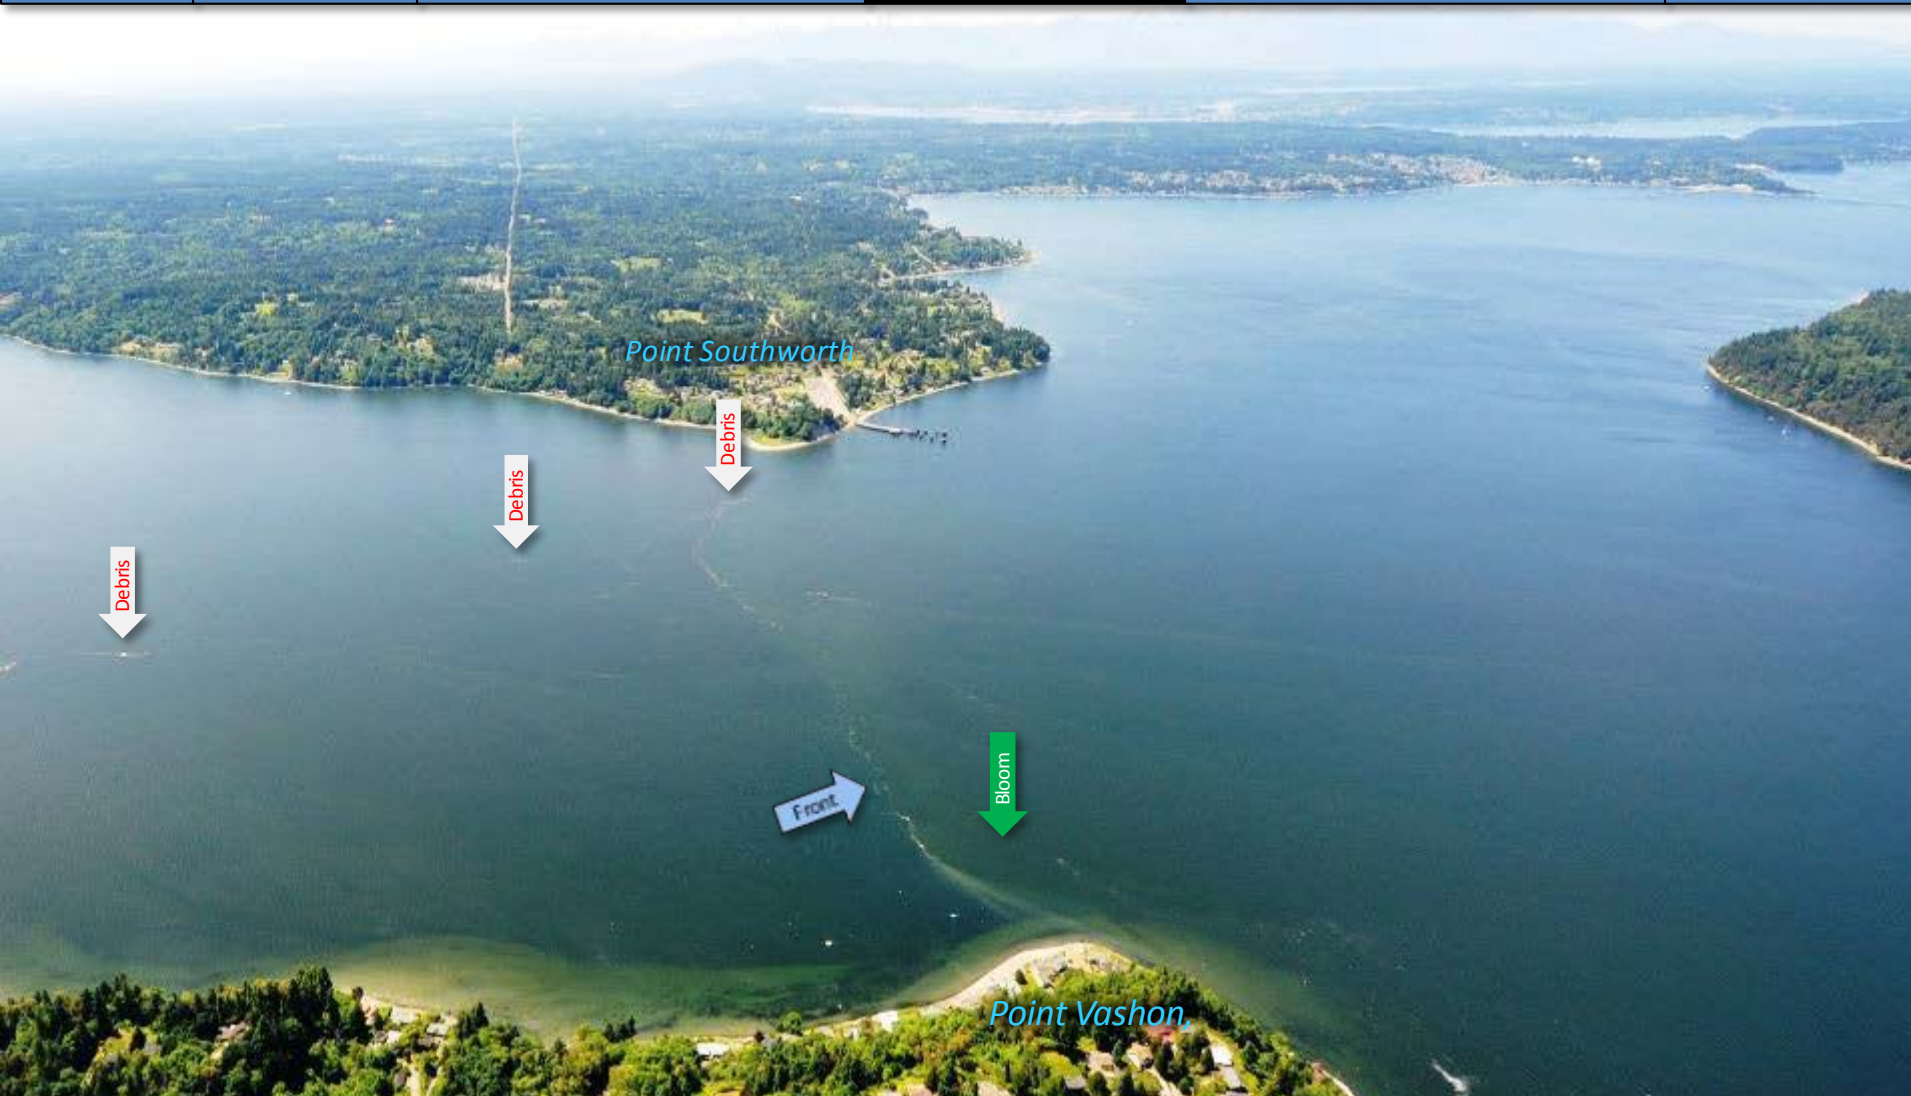
*Tidal front and macro-algae at the entrance and inside Colvos Passage.*  
Location: Point Vashon, Point Southworth, Colvos Passage (Central Sound), 2:30 PM.

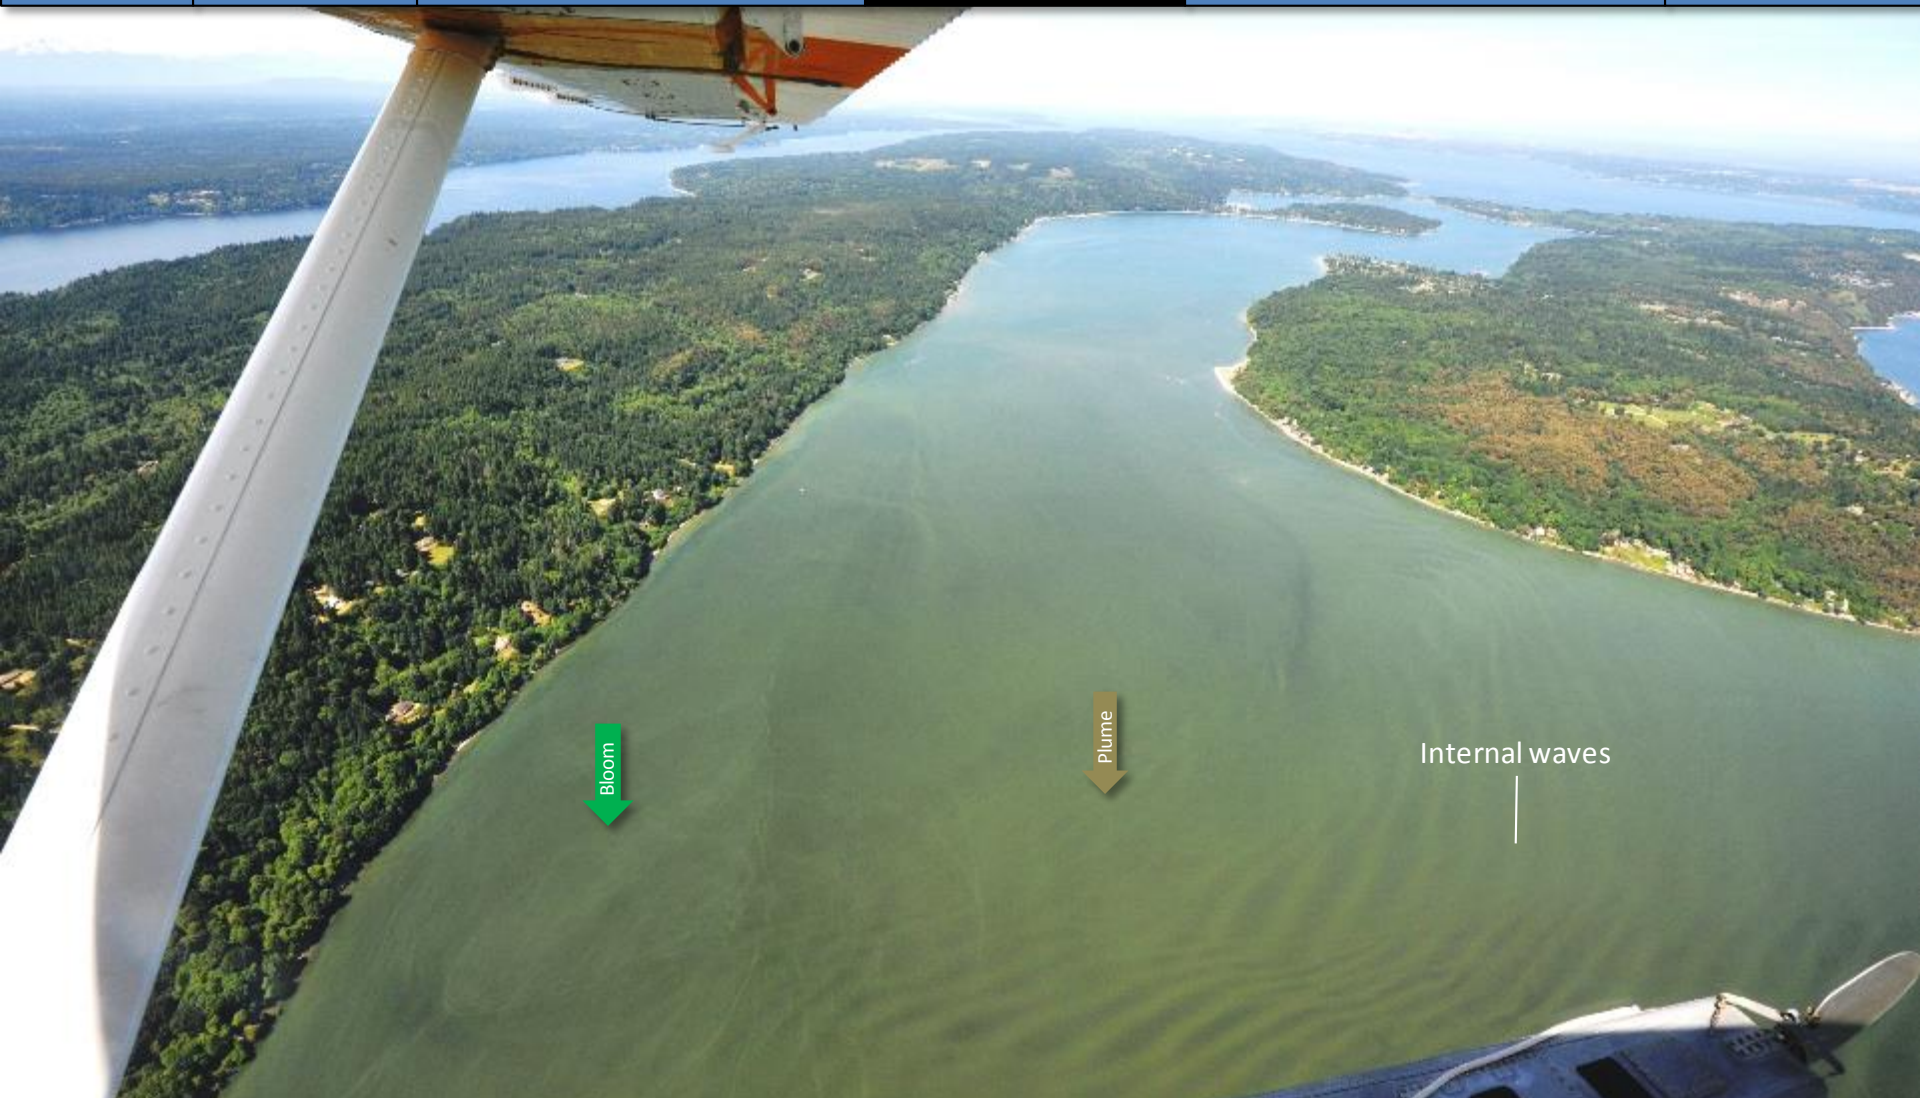
*Internal waves can be seen in sediment rich water of Puyallup River extending into Quartermaster Harbor.  
Location: Vashon Island (Central Sound), 2:36 PM.*

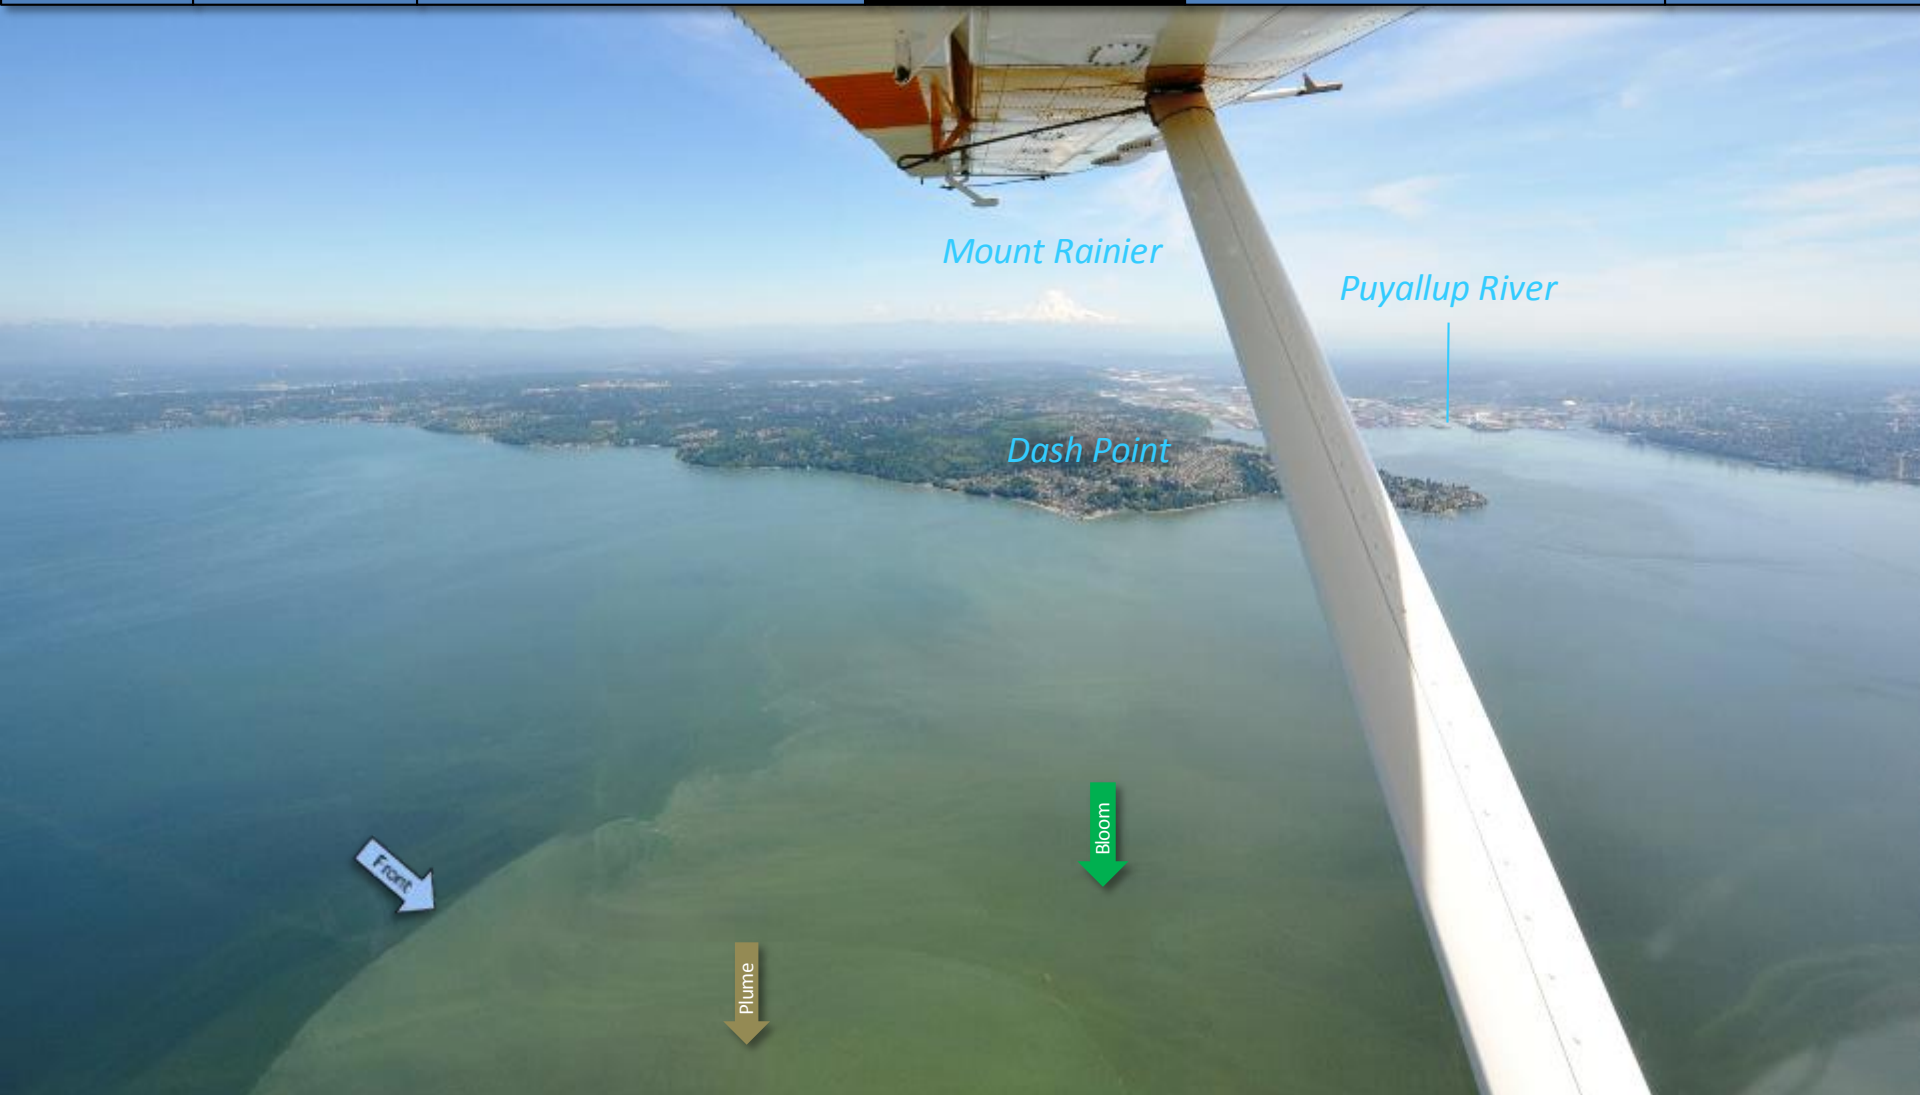
*Puyallup River plume rich in glacial flower entering Commencement Bay.  
Location: Commencement Bay (Central Sound), 2:36 PM.*

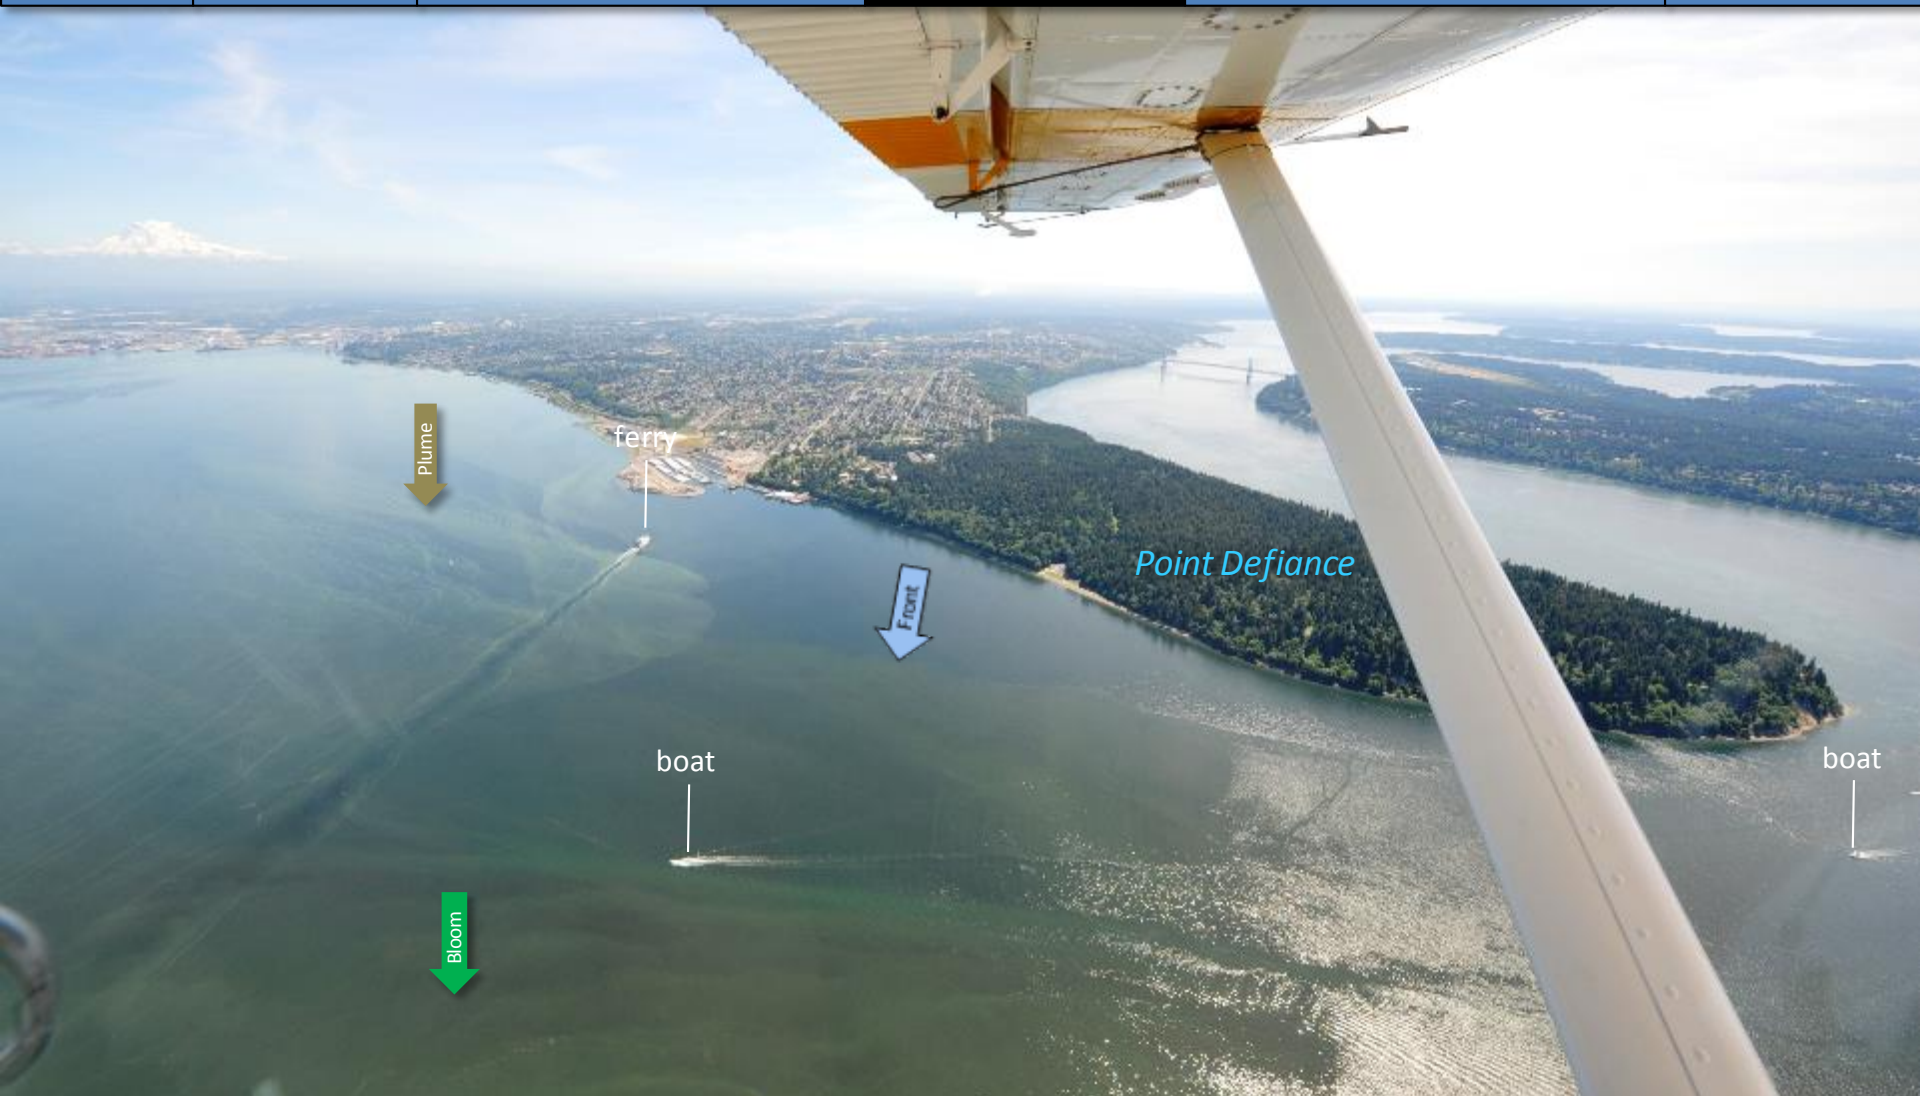
*Red-brown bloom in sediment-rich freshwater plume of the Puyallup River.  
Location: Point Defiance (Central Sound), 2:37 PM.*

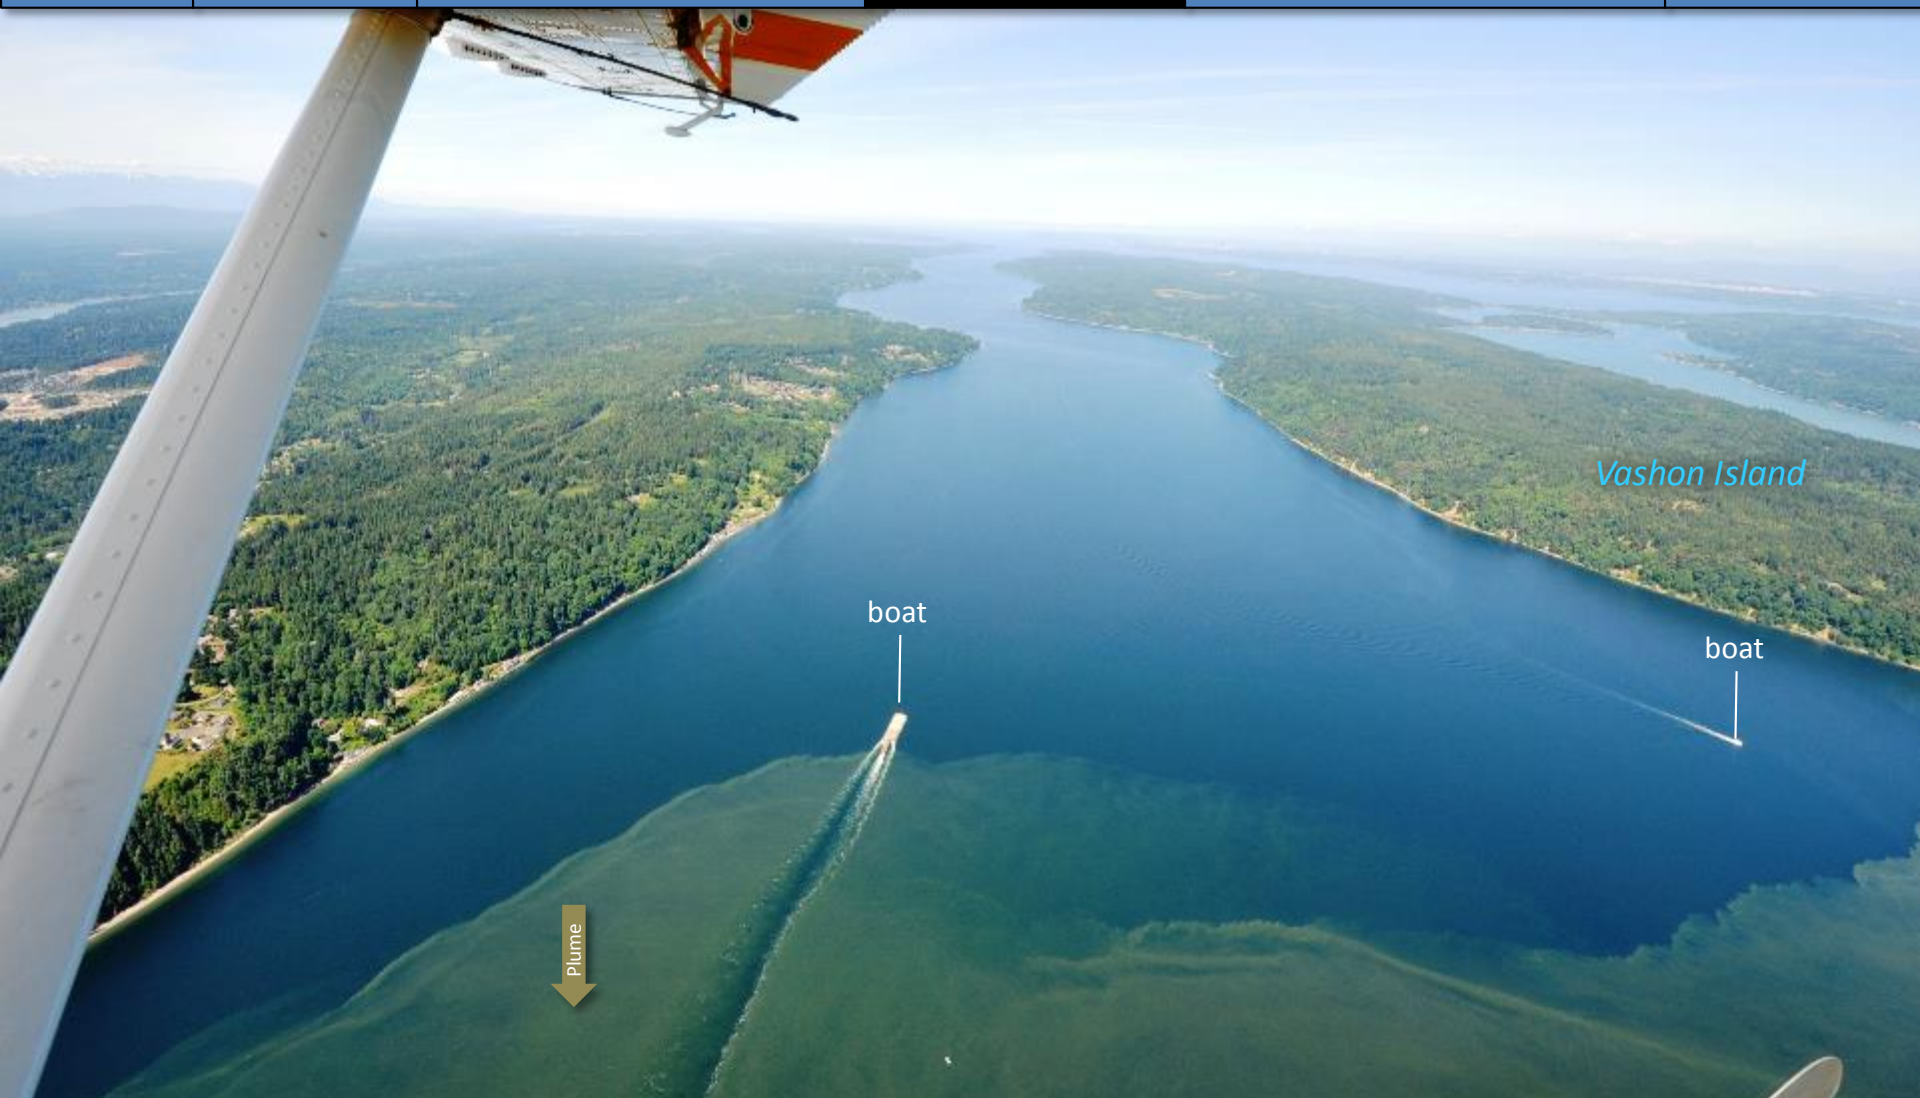
*Sediment plume of the Puyallup River at the entrance to Colvos Passage.  
Location: Point Defiance (Central Sound), 2:38 PM.*

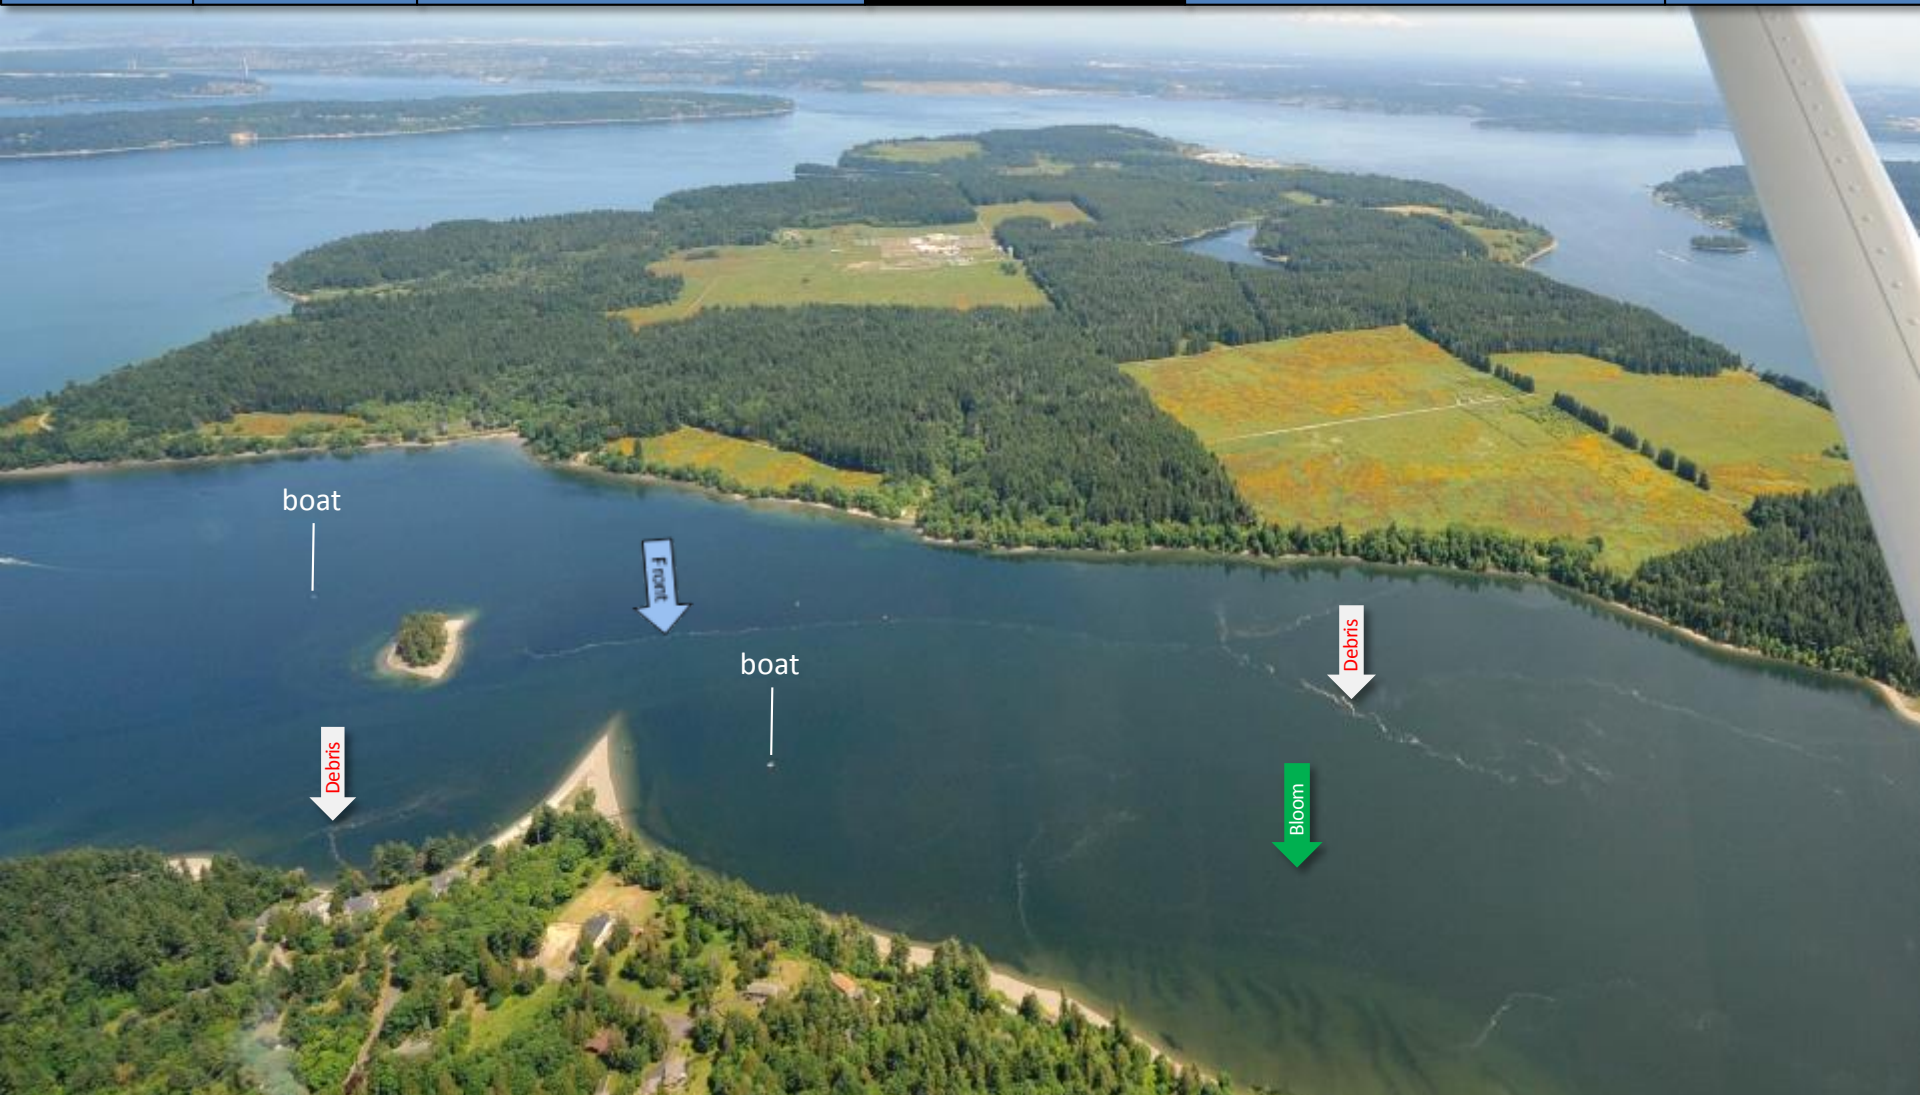
*Bloom and organic material accumulating along tidal fronts.*  
Location: Pitt Passage (South Sound), 2:45 PM.
